BMW X1 - 2019

Vehicle information

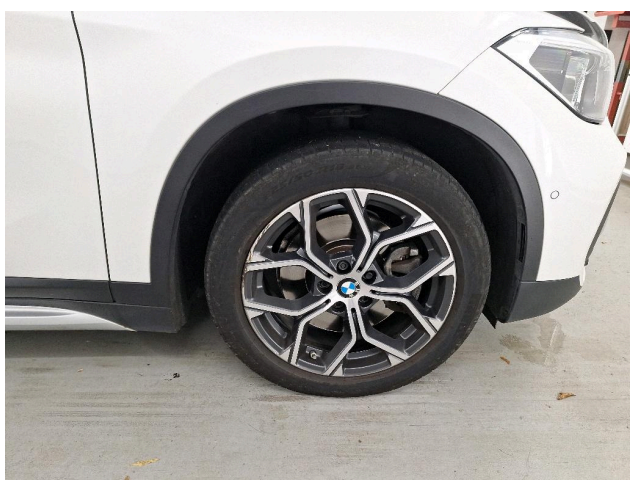
Bodywork
Damaged - Acceptable.
Roof & other
