Expertise

Protocol number: 48509375
Order No. / Reference: 27248297
Inspection date: 2 Nov 2026

Manufacturer: Mercedes-Benz	Model: EQE SUV 350 4MATIC AMG Line Premium
VIN: W1NGM1CB9PA006818

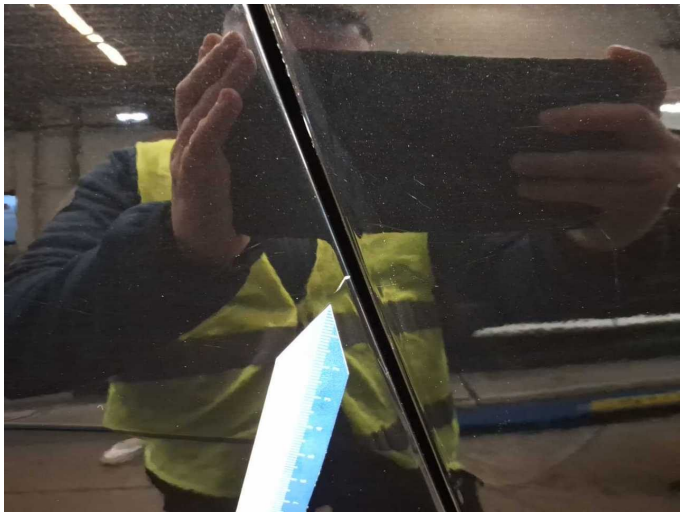
Damage 5: Side panel - rear right side: Side panel - Scratch(es) - Smart repair

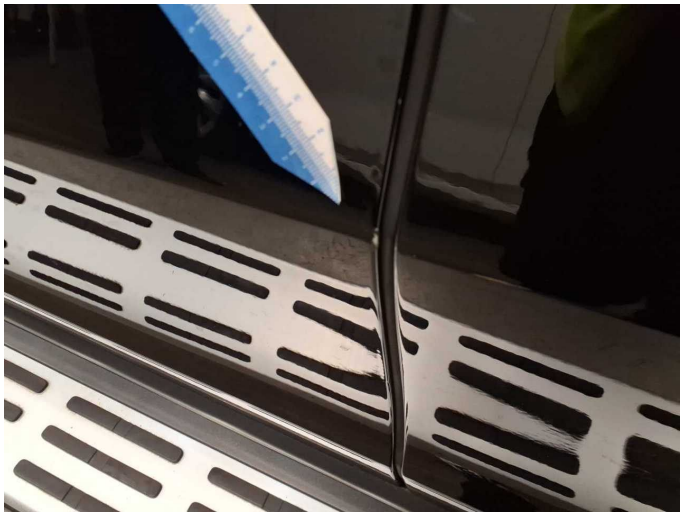
Damage 5: Side panel - rear right side: Side panel - Scratch(es) - Smart repair

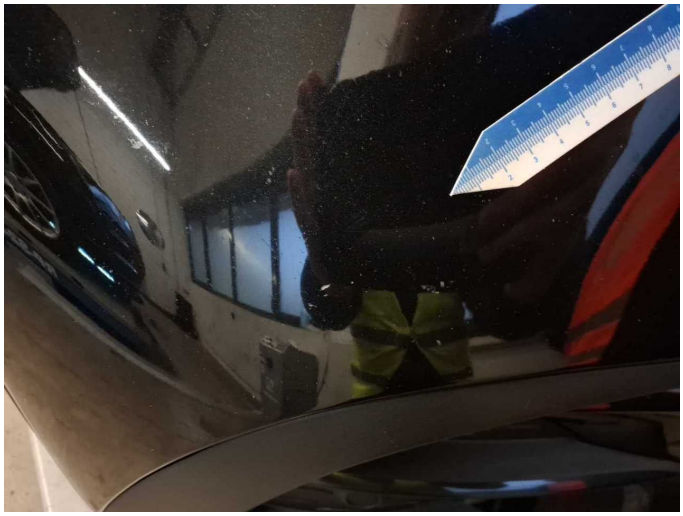
Damage 11: Front bumper: Front bumper (Sandstrahlefekt) - Stone chips - Paint

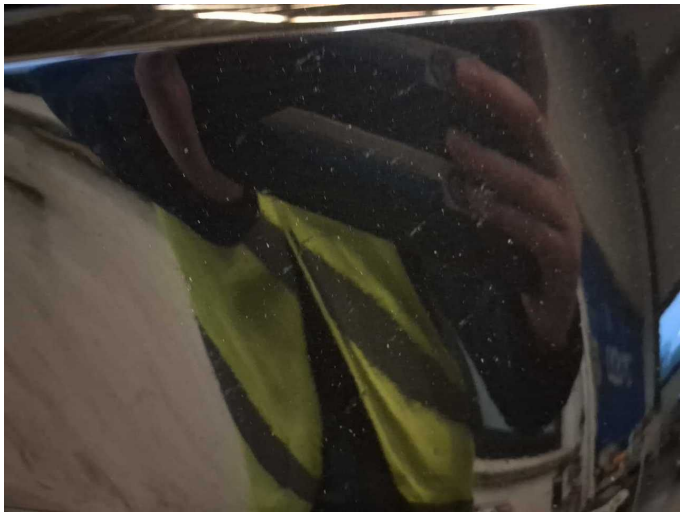
Damage 11: Front bumper: Front bumper (Sandstrahlefekt) - Stone chips - Paint

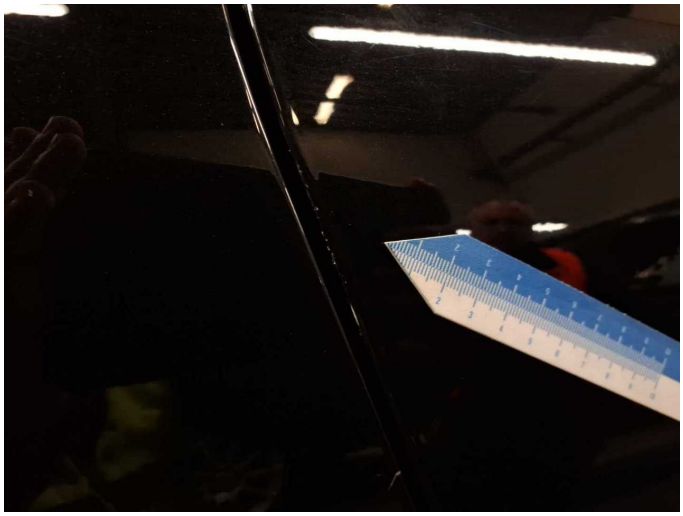
Damage 12: Door - rear right side: Door - Scratch(es) - Paint

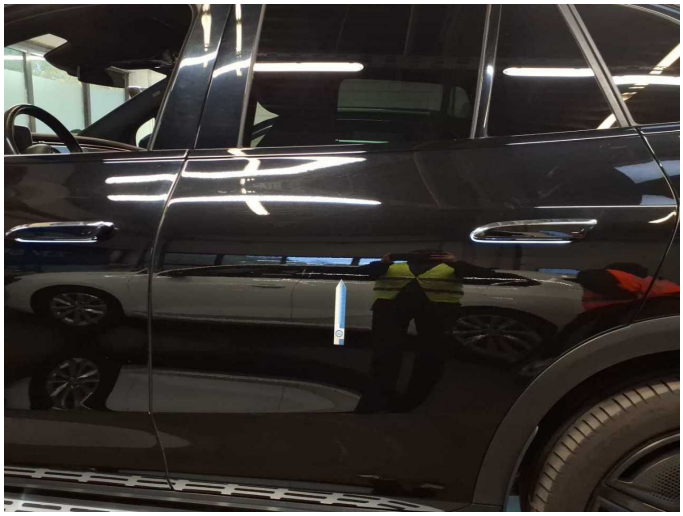
Damage 13: Door - rear left side: Door - Scratch(es) - Paint

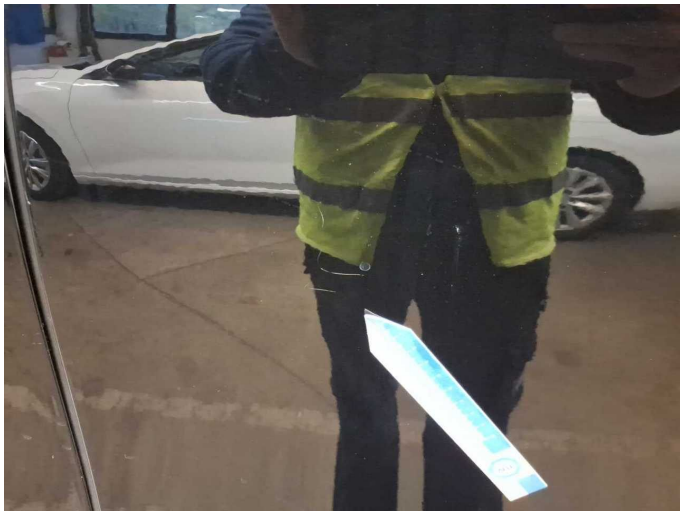
Damage 13: Door - rear left side: Door - Scratch(es) - Paint
