Expertise

Protocol number: 48491867
Order No. / Reference: 27168426
Inspection date: 4 Nov 2026

Manufacturer: Porsche	Model: Panamera 4 E-Hybrid Sport Turismo
VIN: WP0ZZZ97ZML184386

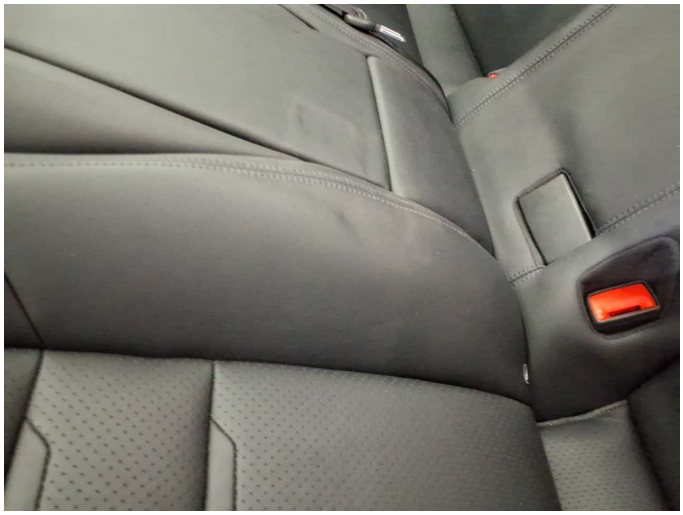
Damage 6: Seat - rear: Seat upholstery - 2 seater bench - Deformed - Loss in value

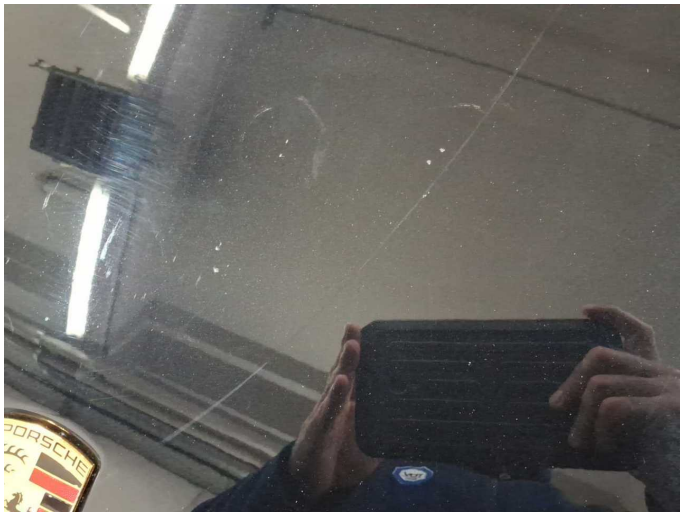
Damage 7: Bonnet: Bonnet - Stone chips - Paint

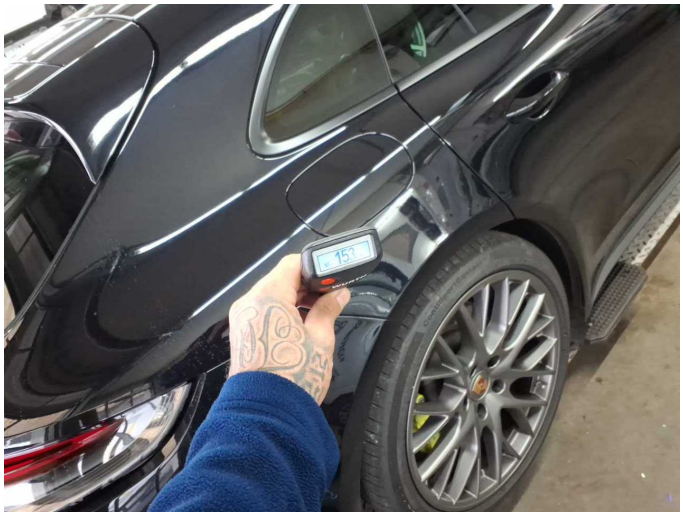
No.	Repainting
1	Boot lid / rear door, Mudguard - right side, Side panel - rear right side, Professionally carried out

Boot lid / rear door	286 µm	Mudguard - right side	313 µm
Side panel - rear right side	153 µm

Repainting 1: Boot lid / rear door, Mudguard - right side, Side panel - rear right side

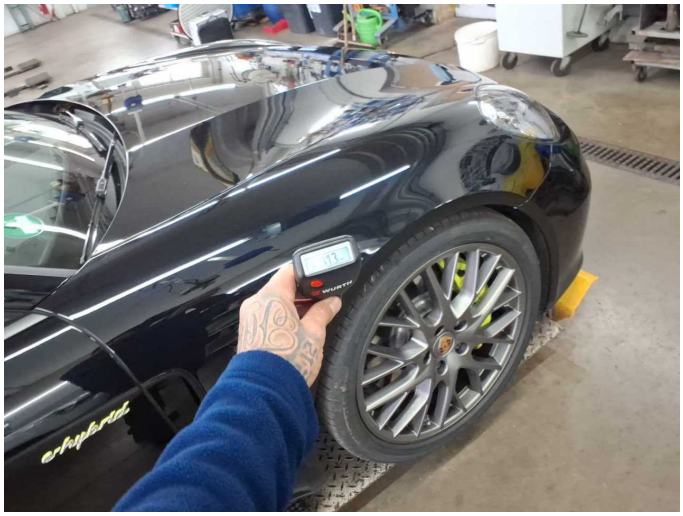
Repainting 1: Boot lid / rear door, Mudguard - right side, Side panel - rear right side
