Expertise

Protocol number: 48211900
Order No. / Reference: 27104141
Inspection date: 12 Oct 2026

Manufacturer: Audi	Model: A6 Avant 40 TDI S tronic
VIN: WAUZZZF21NN066946

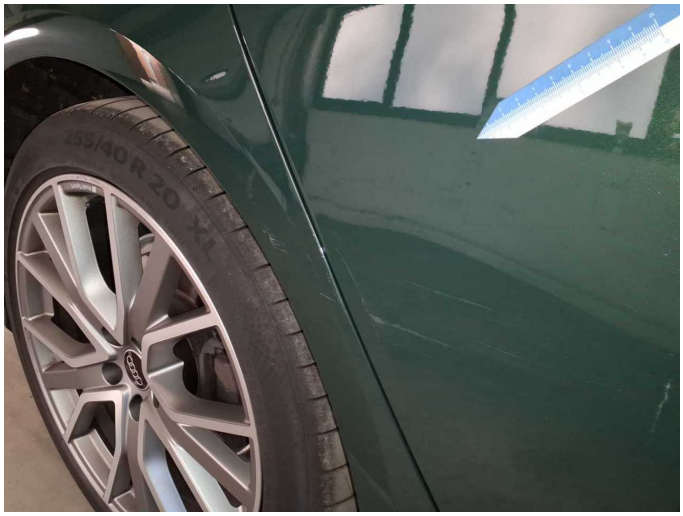
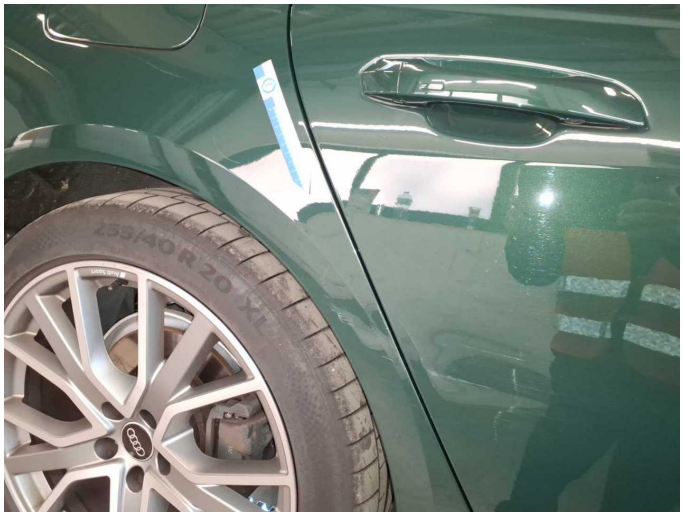
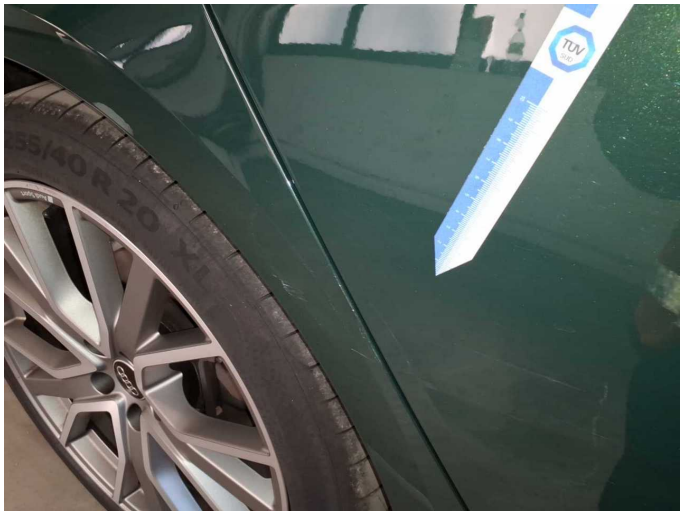
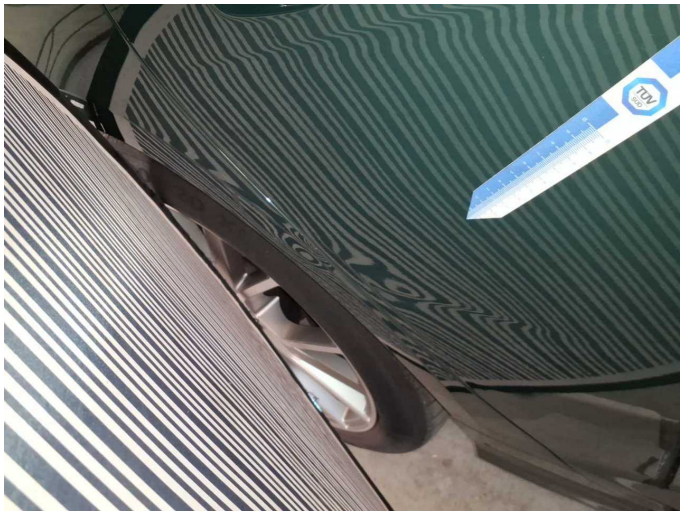
Accident 1: Side right
