Expertise

Protocol number: 48485280
Order No. / Reference: 27258729
Inspection date: 3 Nov 2026

Manufacturer: Mercedes-Benz	Model: E 220 d T 9G-TRONIC
VIN: W1K2132041B080565

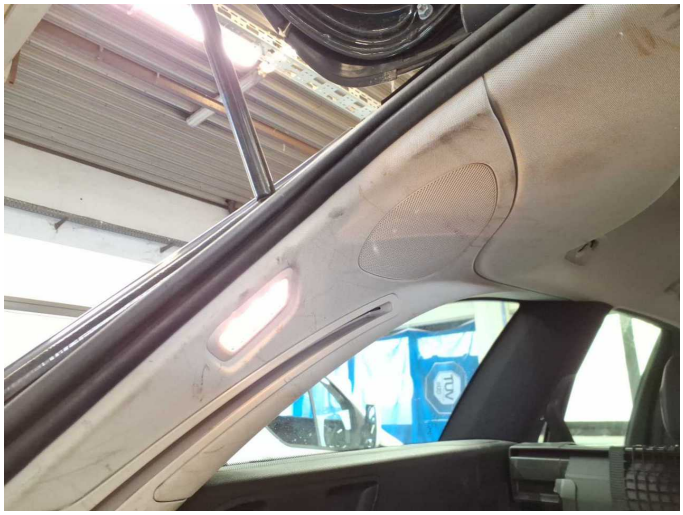
Damage 1: Trim / covers: Roof lining - Soiled - Clean

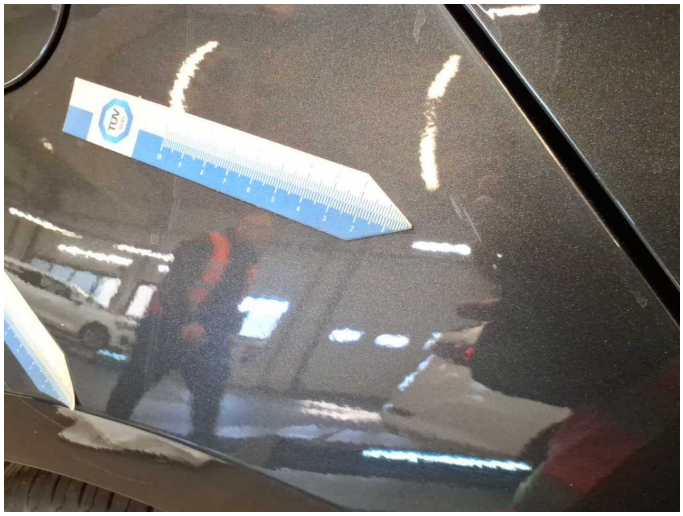
Damage 4: Side panel - rear right side: Side panel - Scratch(es) - Smart repair

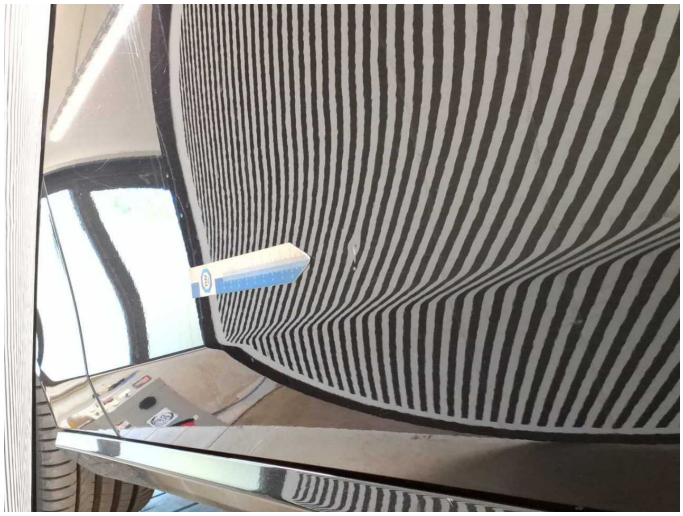
Damage 13: Door - front left side: Door - Dent / paintcoat damage - Repair and paint
