TÜV SÜD Auto Partner GmbH
Wiesenring 2
04159 Leipzig

Expertise

Protocol number: 48509233
Order No. / Reference: 27241092
Inspection date: 3 Nov 2026

Manufacturer: Volkswagen	Model: Tiguan 1.4 eHybrid OPF DSG R-Line
VIN: WVGZZZ5NZMW405397

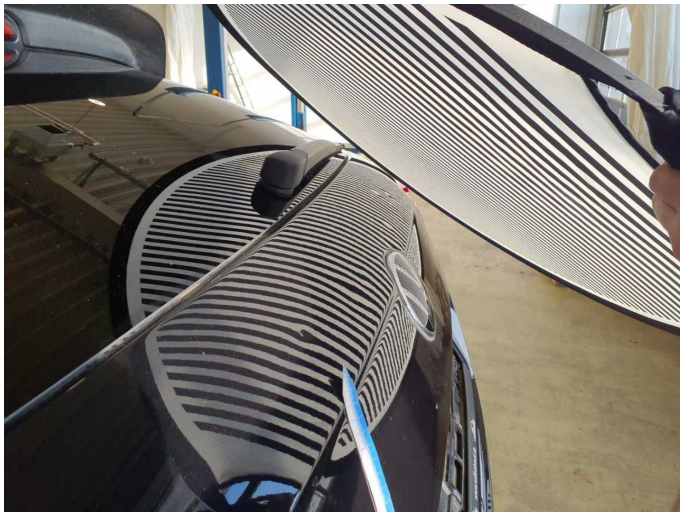
Damage 3: Boot lid / rear door: Boot lid - dent(s) - Smooth repair work

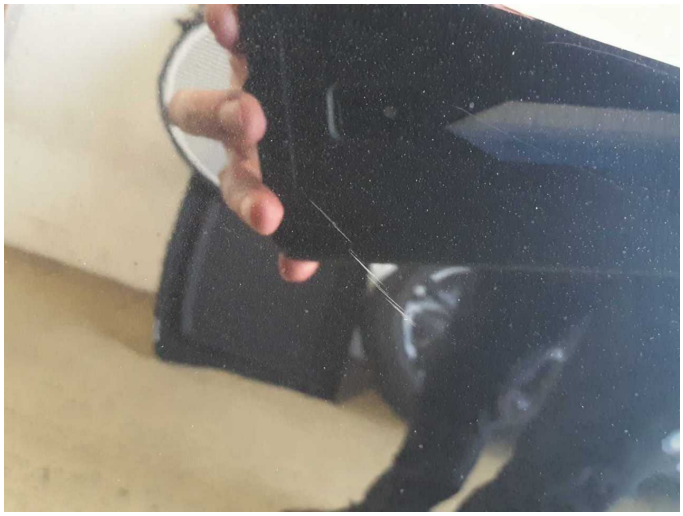
Damage 5: Door - rear left side: Door - Scratch(es) - Smart repair

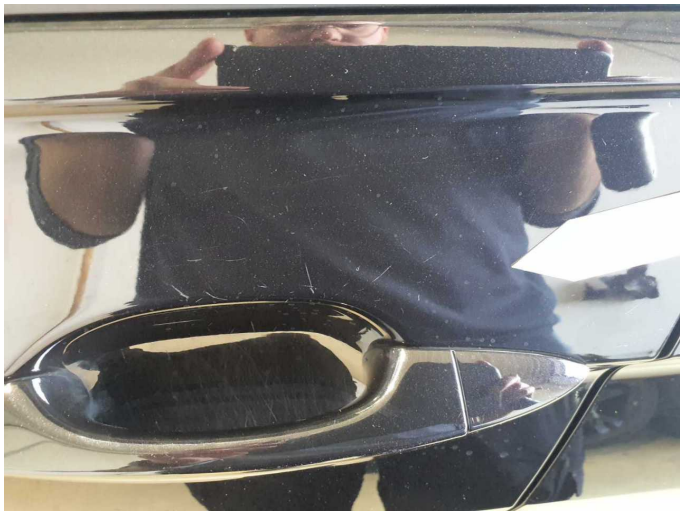
Damage 5: Door - rear left side: Door - Scratch(es) - Smart repair

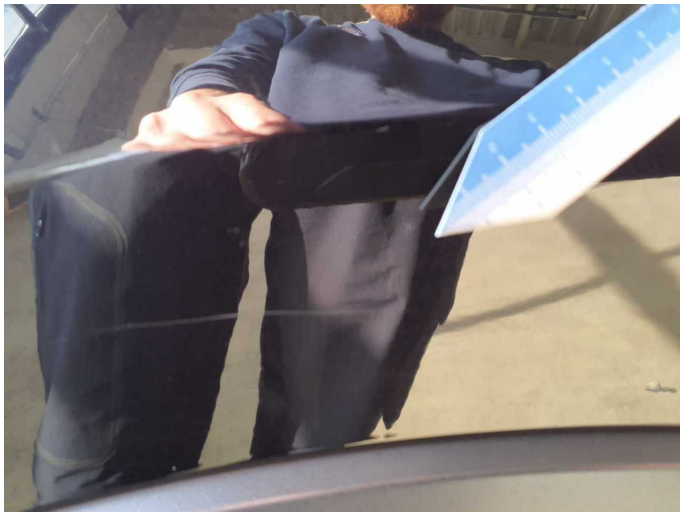
Damage 8: Side panel - rear right side: Side panel - Scratch(es) - Smart repair

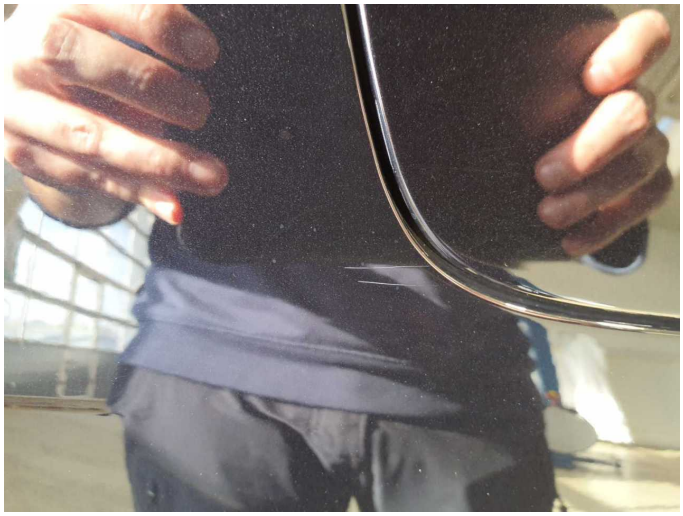
Damage 8: Side panel - rear right side: Side panel - Scratch(es) - Smart repair

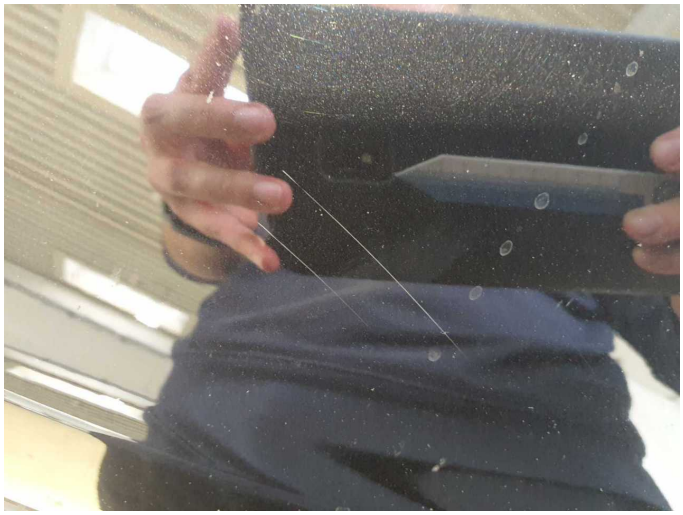
Damage 11: Side panel - rear right side: Wheel well extension - Scratch(es) - Replace

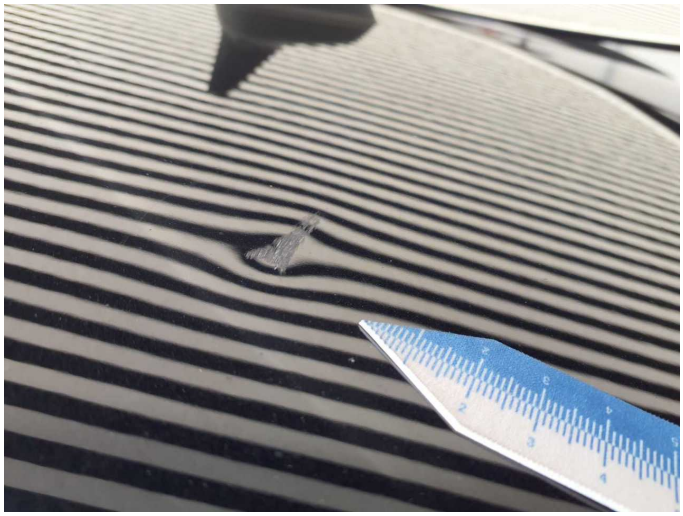
Damage 14: Door - rear right side: Door - Scratch(es) - Paint

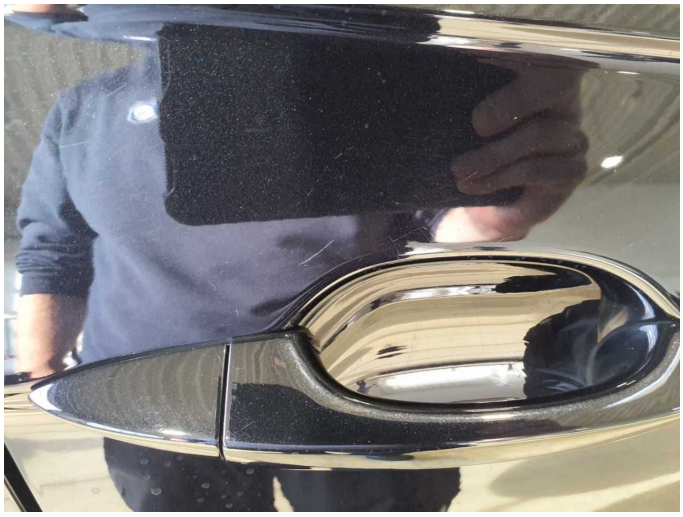
Wear and tear 3: Door - front right side: Door - Dent / paintcoat damage - No deduction
