MACADAM
BYD Atto 3 '22 BEV

Vehicle information

Damage summary

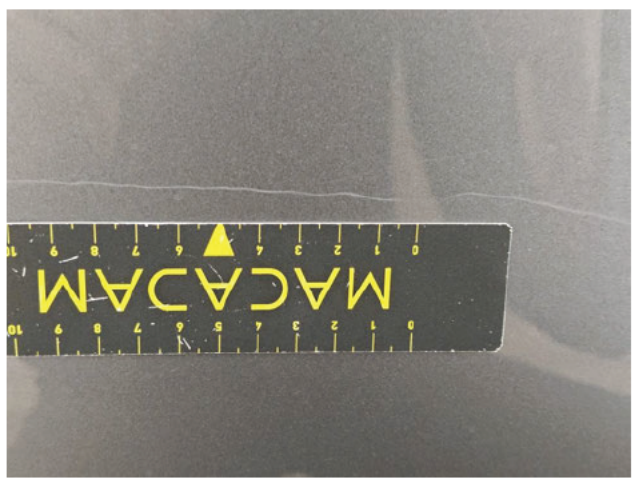
Boot lid covering R
Scratch(es)
Smart repair
Rear
