Expertise

Protocol number: 48111537
Order No. / Reference: 26920469
Inspection date: 13 Oct 2026

Manufacturer: Skoda	Model: Octavia Combi 2.0 TDI DSG RS
VIN: TMBJK8NXXPY091812

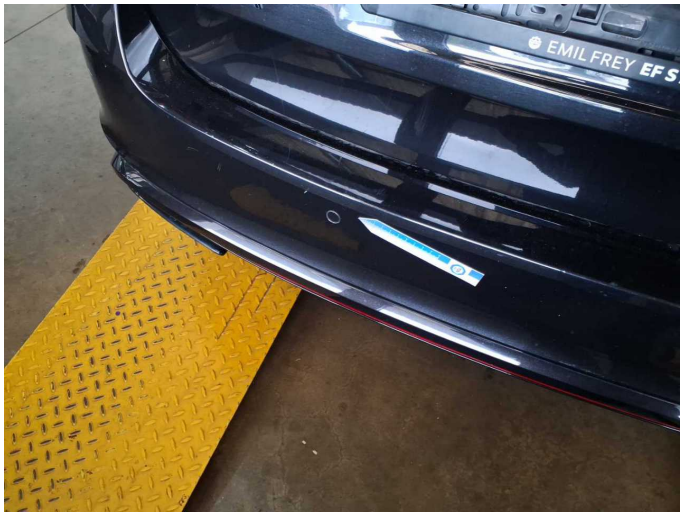
Damage 11: Rear bumper: Rear bumper - Scratch(es) - Paint

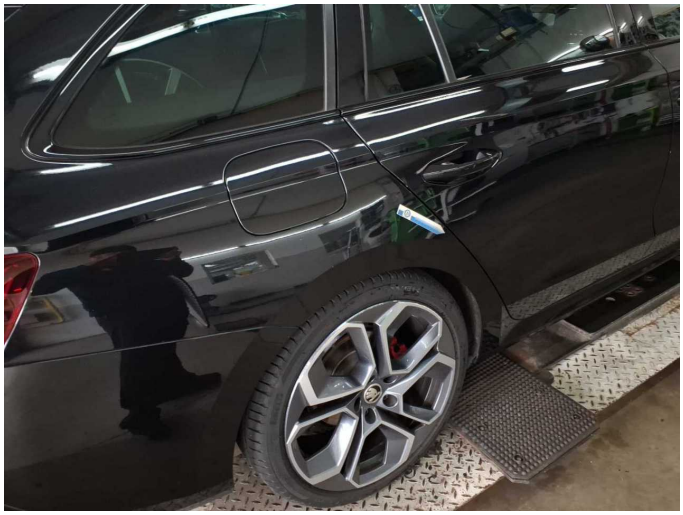
Wear and tear 6: Wheel / tyres: Alloy rim - rear left side - Scratch(es) - No deduction
