Expertise

Protocol number: 48112376
Order No. / Reference: 26826441
Inspection date: 14 Oct 2026

Manufacturer: Audi	Model: A4 Avant 40 TDI S tronic
VIN: WAUZZZF44PA069240

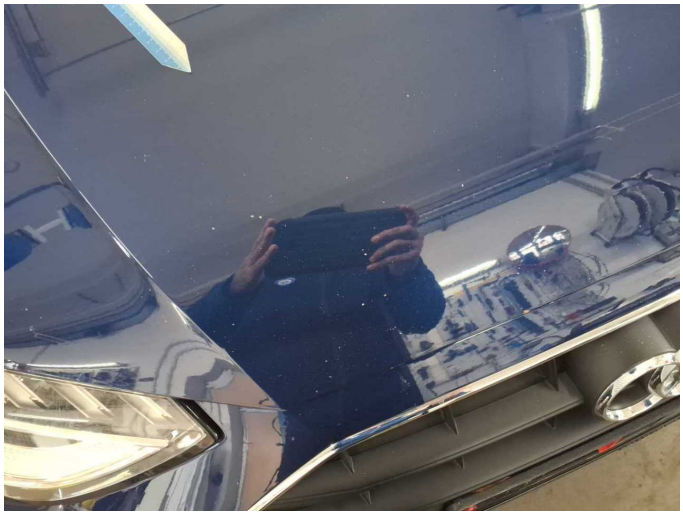
Damage 4: Bonnet: Bonnet (+ Korrosion) - Stone chips - Repair and paint

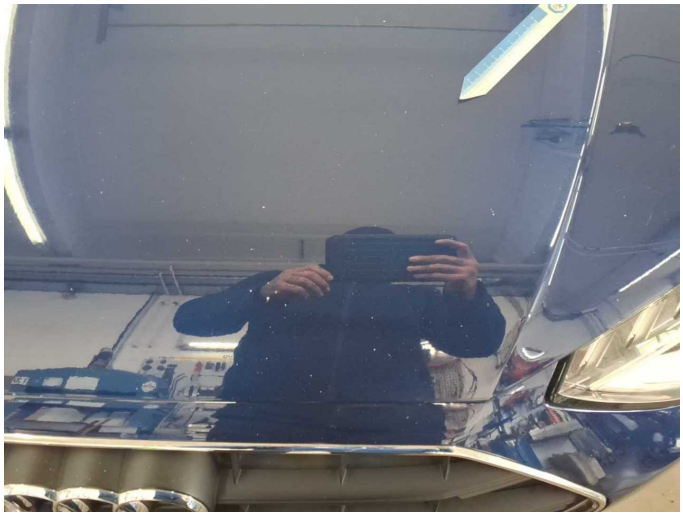
Damage 4: Bonnet: Bonnet (+ Korrosion) - Stone chips - Repair and paint

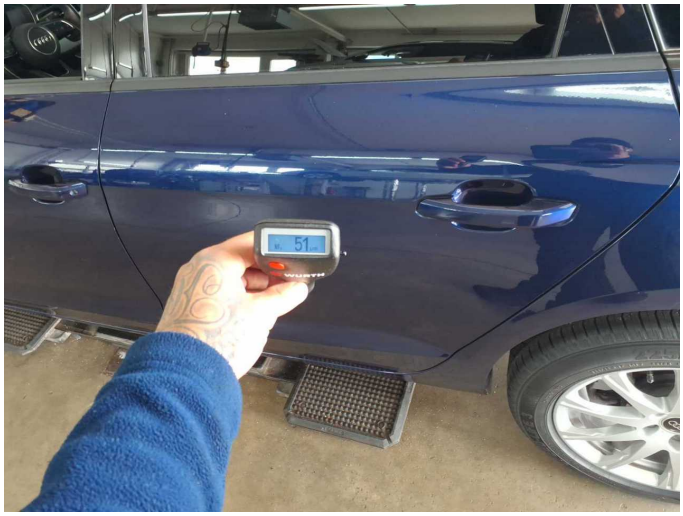
According to available information previous damages were repaired at the vehicle. Traces of repairs, which allow conclusions about the area of repair, were not recognizable during the inspection.

Previous damage 1: Rear, Side - left
