Expertise

Protocol number: 48416081
Order No. / Reference: 27211646
Inspection date: 28 Oct 2026

Manufacturer: Kia	Model: Sorento 2.2 CRDi DCT8 2WD Spirit
VIN: KNARH81BGP5222363

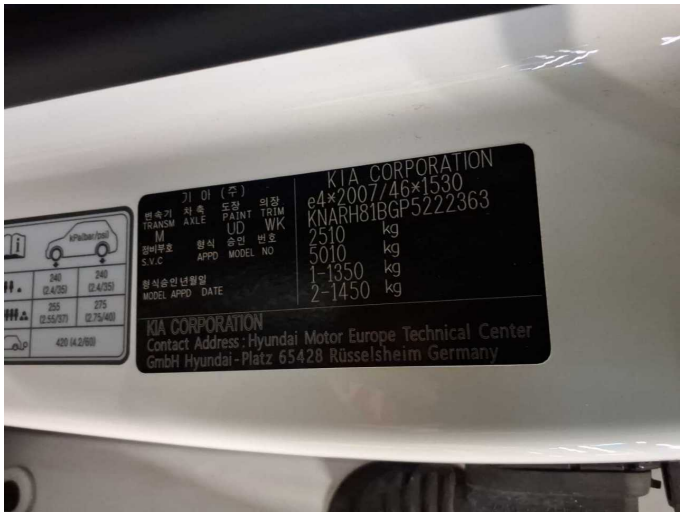
Figure 11: VIN

Documents submitted	At the time of the inspection, the vehicle registration certificate Part 2 (title) was available, but the vehicle registration certificate Part 1 (document) was not. (Copy)
VIN comparison	The vehicle identification number (VIN) was read from the vehicle and its conformity with the submitted documents was confirmed by the undersigned during the inspection.
Inspection	The inspection conditions were sufficient for the assessment of the vehicle. Lifting equipment and/or a pit were available for examining the vehicle.
Test drive	No test drive/shunting maneuver was carried out during the inspection of the vehicle.
Engine function test	An engine test run was performed.
