APPRAISAL REPORT

Driver name:	HM Tongeren
Make:	VOLKSWAGEN
Model / version:	Tiguan
Wine:	WVGZZZ5NZMM142557
Plate:	2BAX911
Mileage:	94336
First registration:	14/09/2021
Color:	Platinum Gre

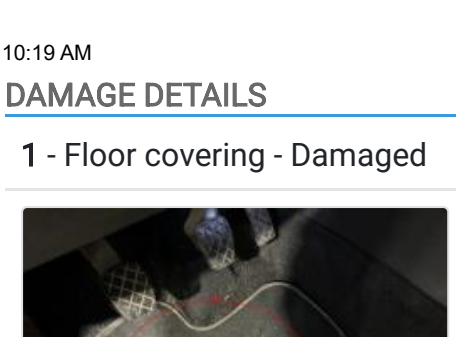
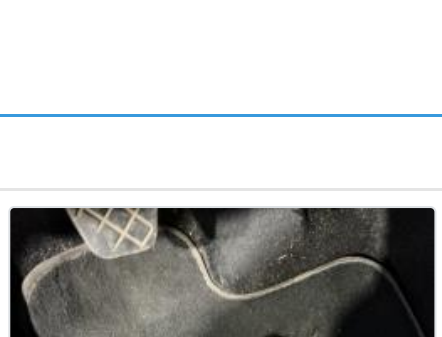
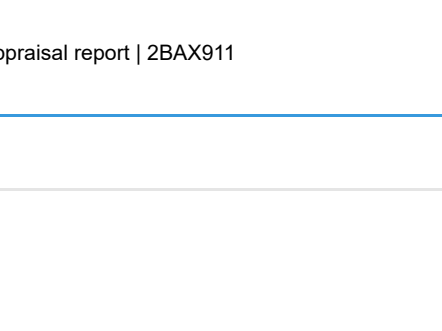
1 - Floor covering - Damaged
