TÜV SÜD Auto Partner GmbH
Wiesenring 2
04159 Leipzig

Expertise

Protocol number: 48443163
Order No. / Reference: 27171121
Inspection date: 2 Nov 2026

Manufacturer: Mercedes-Benz	Model: GLC 300 d 4Matic 9G-TRONIC AMG Line Premium Plus (Advanced)
VIN: W1NKM0HB8RU047343

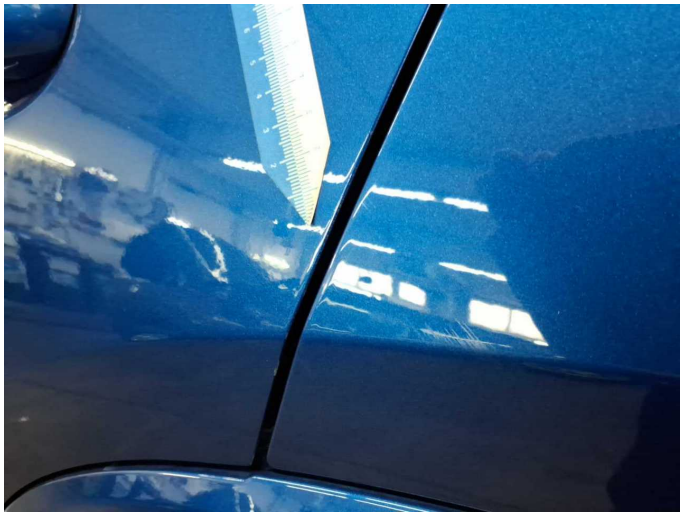
Damage 1: Door - rear left side: Door edge - Scratch(es) - Smart repair

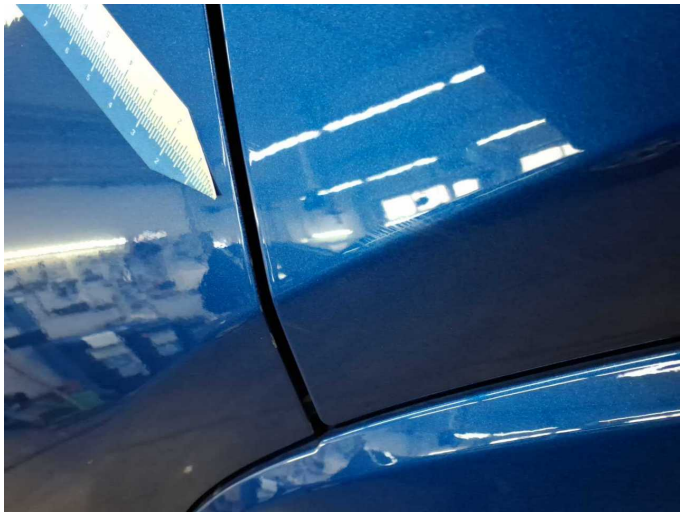
Damage 1: Door - rear left side: Door edge - Scratch(es) - Smart repair

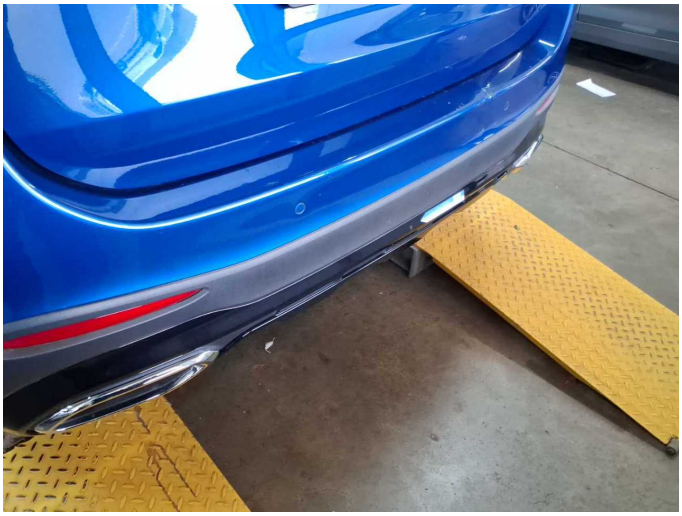
Damage 2: Rear bumper: Spoiler - Scratch(es) - Smart repair

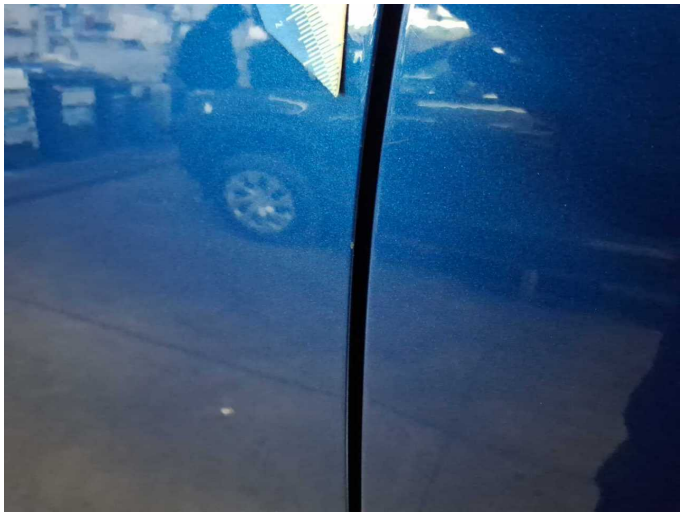
Damage 3: Door - front left side: Door edge - Scratch(es) - Smart repair

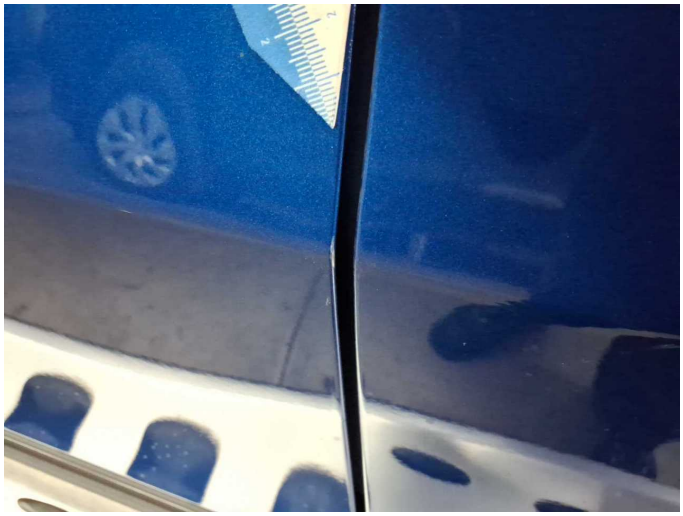
Damage 3: Door - front left side: Door edge - Scratch(es) - Smart repair

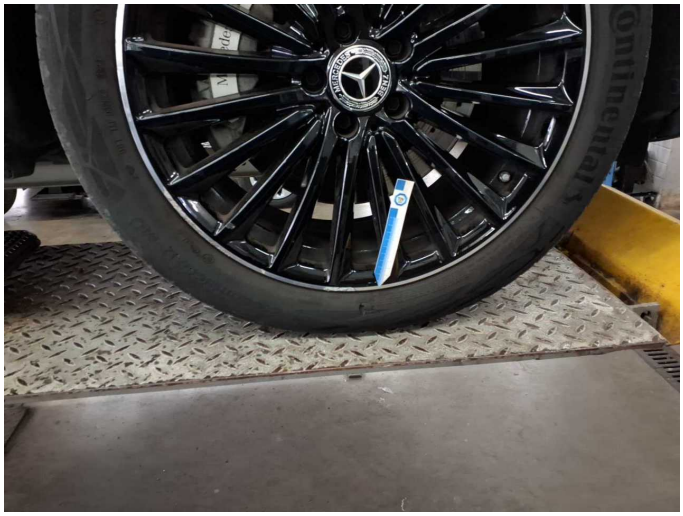
Damage 4: Wheel / tyres: Alloy rim - rear left side - Scratched - Loss in value

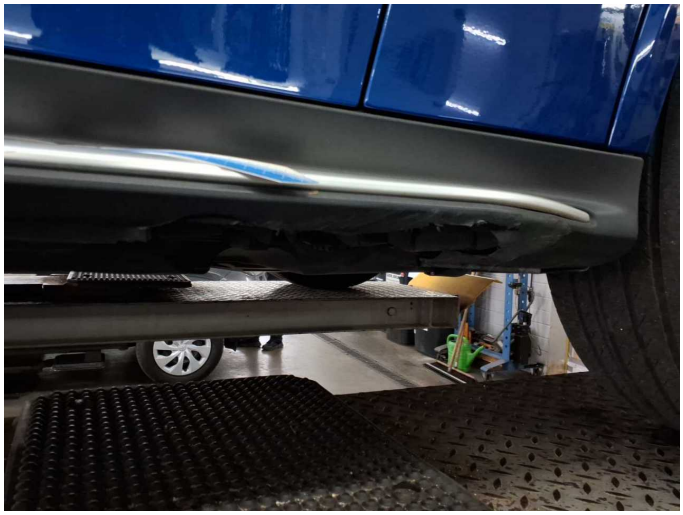
Damage 6: Sill - right side: Cat walk - Broken / torn - Replace

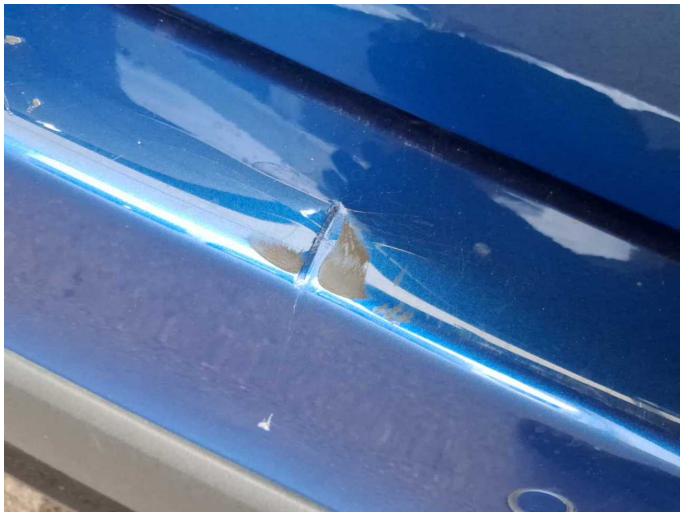
Damage 9: Rear bumper: Rear bumper (Eingedrückt/Delle) - Scratched - Replace

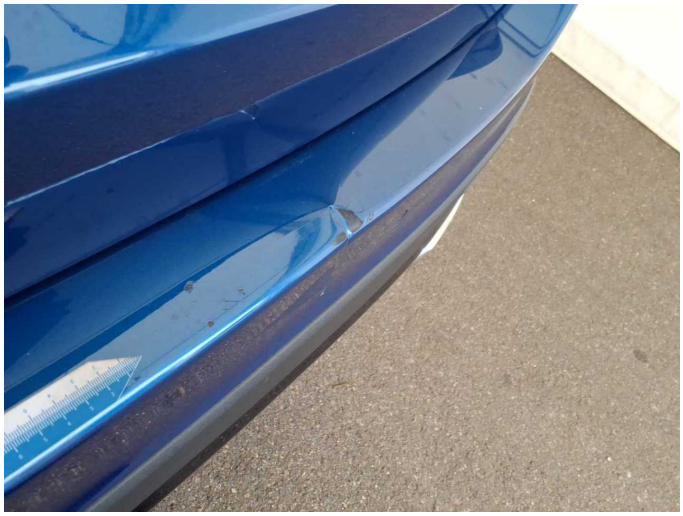
Damage 9: Rear bumper: Rear bumper (Eingedrückt/Delle) - Scratched - Replace

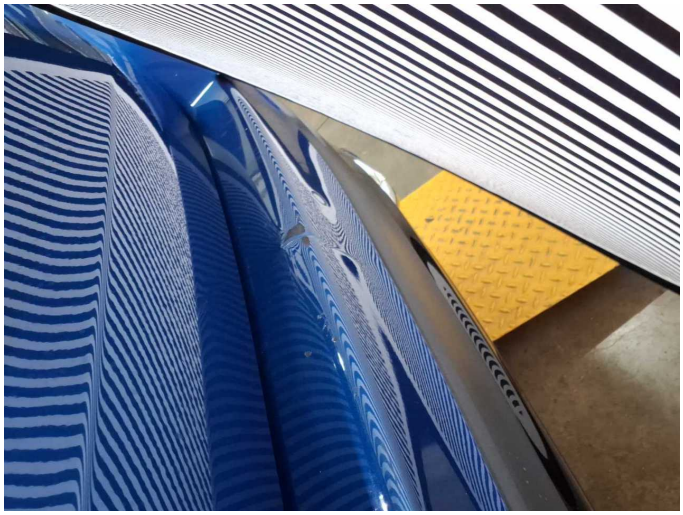
Damage 9: Rear bumper: Rear bumper (Eingedrückt/Delle) - Scratched - Replace

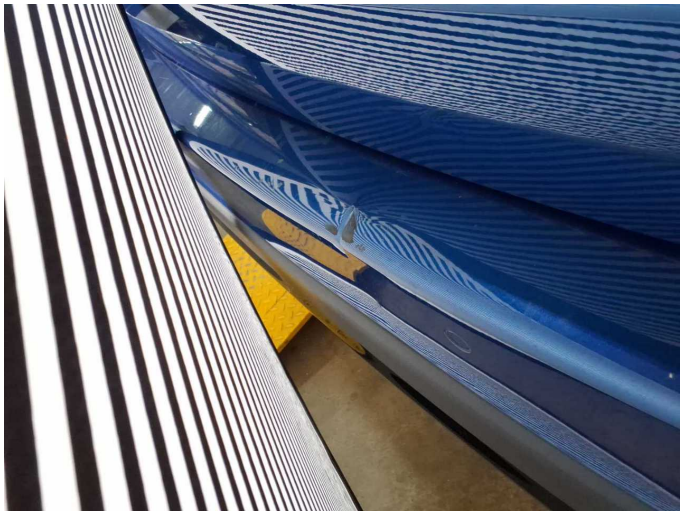
Damage 9: Rear bumper: Rear bumper (Eingedrückt/Delle) - Scratched - Replace

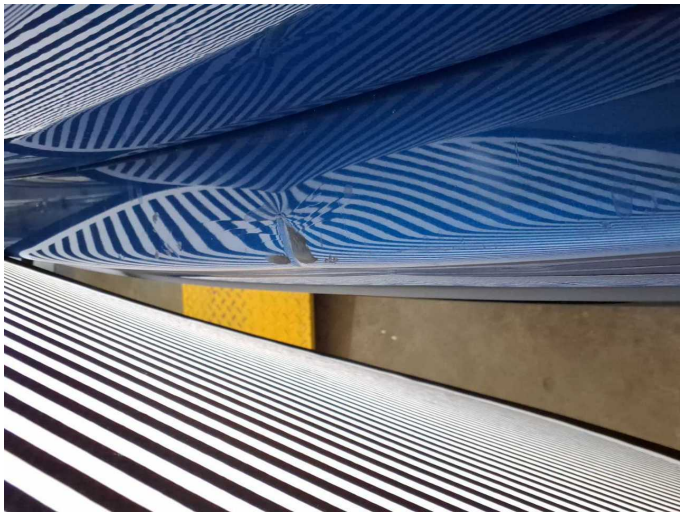
Damage 9: Rear bumper: Rear bumper (Eingedrückt/Delle) - Scratched - Replace

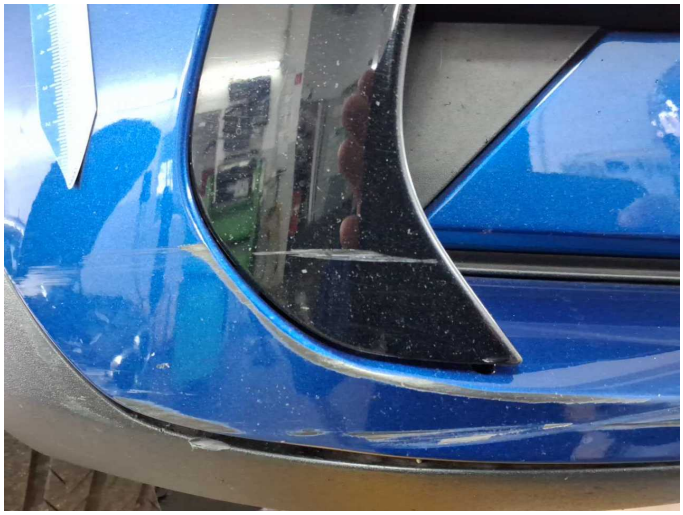
Damage 10: Front bumper: Front bumper - Scratched - repair according to calculation
