BMW

VIN: WBA6M510X0FL73583

Statement details

Inspection loc PARC HÖDLMAYR TONGEREN	**Statement date** 22/10/2026	**Inspection approval date** 23/10/2026

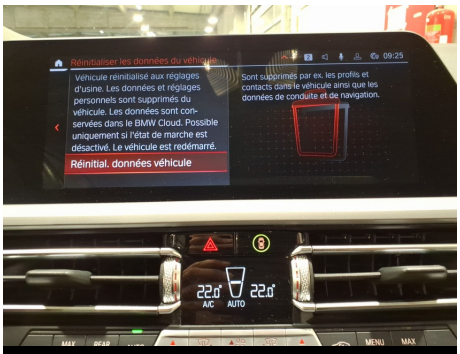
Personal Data / - / Non Compliant

Rim / Front Right / Scratched

Bumper / Back / Scratched

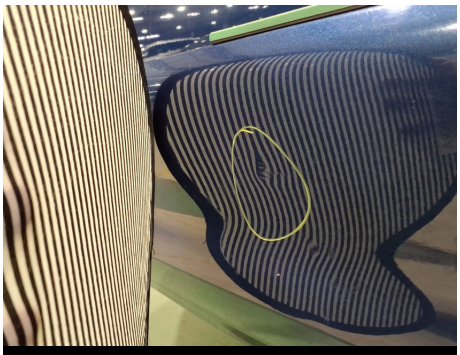
003	Bumper / Back [1] Painted : Yes	Scratched	Painting

[1] Rayures + enfoncement

Bumper / Back / Scratched

Wing / Back Right / Scratched

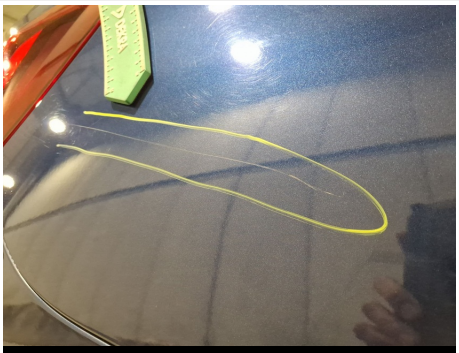
Wing / Back Right / Scratched

Door / Back Right / Dent

Door / Front Right / Chip

Door sill / Front Right / Scratched

Tailgate / Boot door / - / Sticker

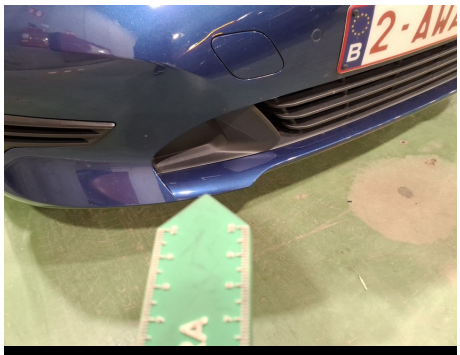
Door sill / Back Left / Scratched

Exterior door mirror shell / Right / Scratched

Bumper / Front / Scratched
