Expertise

Protocol number: 48541873
Order No. / Reference: 27248875
Inspection date: 4 Nov 2026

Manufacturer: Audi	Model: A6 Avant 40 TDI quattro S tronic sport
VIN: WAUZZZF21PN060633

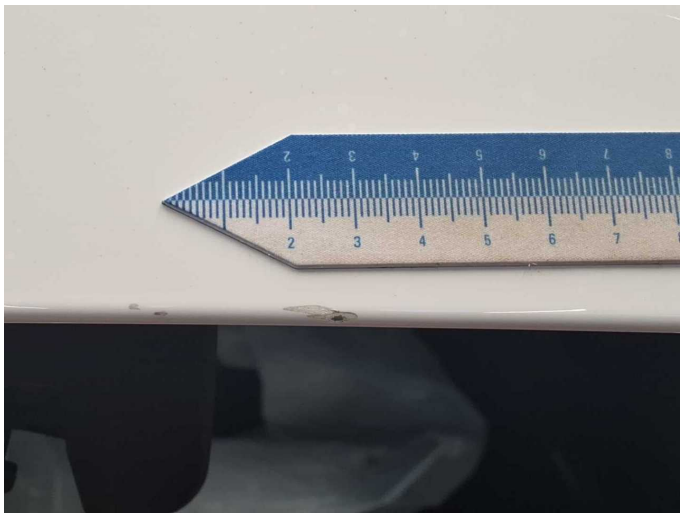
Damage 1: Boot lid / rear door: Boot lid - Scratch(es) - Smart repair
