Expertise

Protocol number: 48368264
Order No. / Reference: 27182619
Inspection date: 26 Oct 2026

Manufacturer: Ford	Model: Transit Custom 280 L1H1 LKW VA Trend
VIN: WF0YXXTTGYLC53280

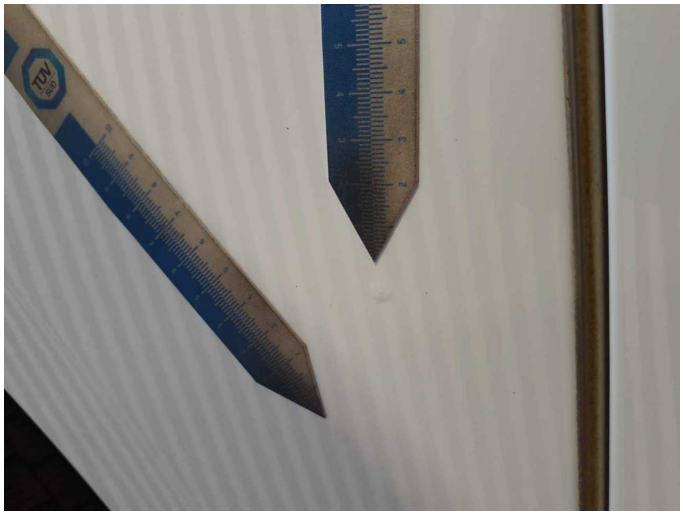
No.	Component group	Description
1	Misc.	Inspection / maintenance - No evidence - No deduction
2	Misc.	Main inspection - No evidence - No deduction
3	Instrument panel	Indicator light (Reifendruck) - on - Perform diagnosis
4	Side panel - rear right side	Elbow - Corrosion - Smart repair

Damage 4: Side panel - rear right side: Elbow - Corrosion - Smart repair
