SKODA KODIAQ (NS)(2016->) AMBITION MOTEUR 2,0 LITRE(S) - 110 KW TDI 5 PORTES

VIN: TMBJJ7NS6P8530523

Statement details

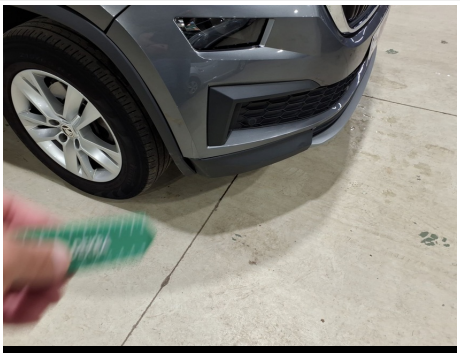
Bumper / Front / Broken

Bumper moulding / Front Right / Broken

Windscreen / - / Chip

006	Bumper / Front Painted : Yes	Broken	Replace

007	Bumper moulding / Front Right Painted : No / Chromed : No	Broken	Replace

008	Windscreen / - Rain sensor : Yes	Chip	Acceptable
