Expertise

Protocol number: 48504696
Order No. / Reference: 27241119
Inspection date: 3 Nov 2026

Manufacturer: Opel	Model: Corsa-e Edition
VIN: VXKUHZKXZN4474447

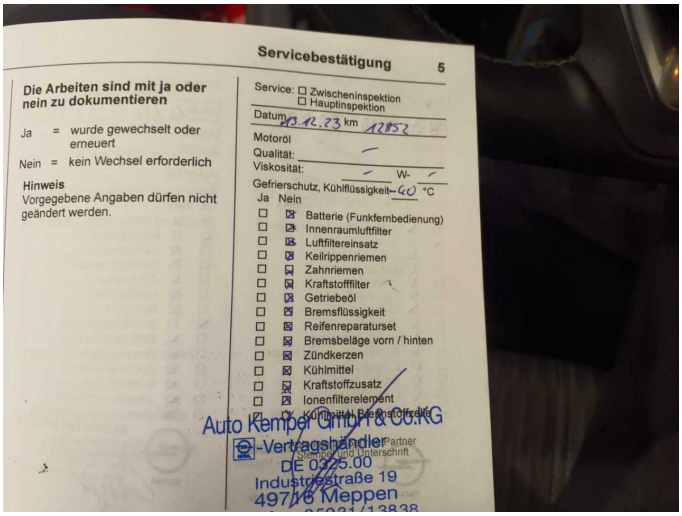
Figure 13: Documents

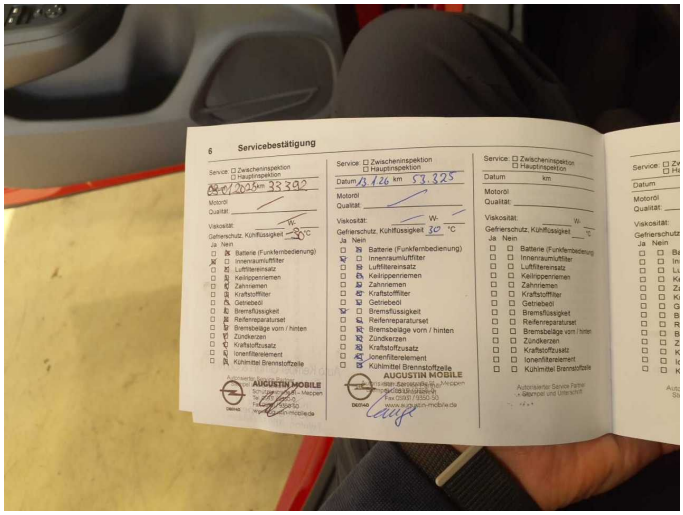
Figure 14: Documents

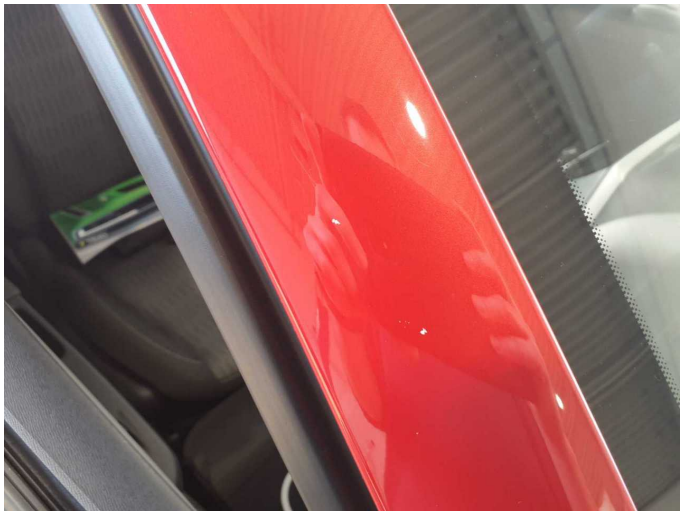
Damage 1: Body: A-pillar - right side - Stone chips - Smart repair

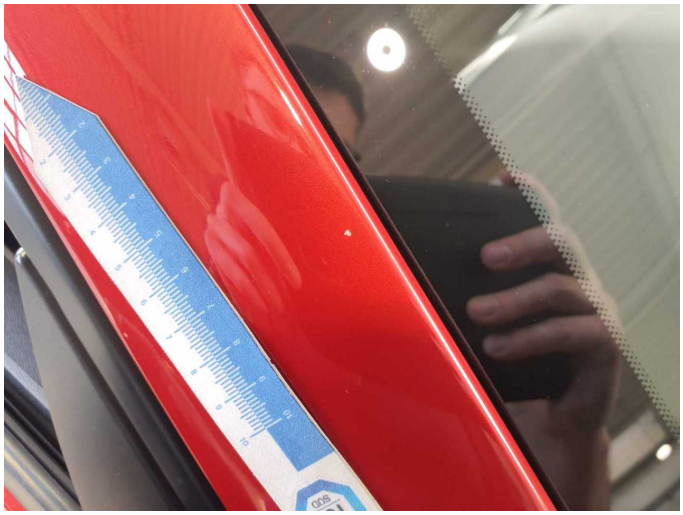
Damage 1: Body: A-pillar - right side - Stone chips - Smart repair
