Expertise

Protocol number: 48283917
Order No. / Reference: 27130865
Inspection date: 23 Oct 2026

Manufacturer: Audi	Model: A4 Avant 50 TDI quattro tiptronic S line
VIN: WAUZZZF47RA125772

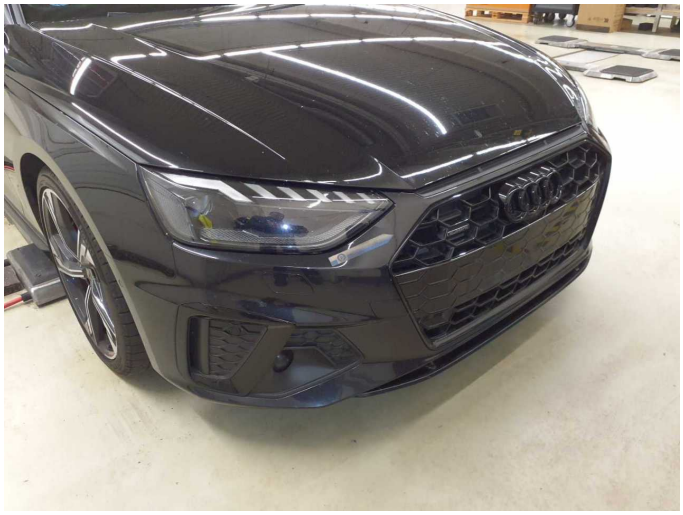
Damage 3: Front bumper: Front bumper (Lackablösung) - Paint defect - Repair and paint

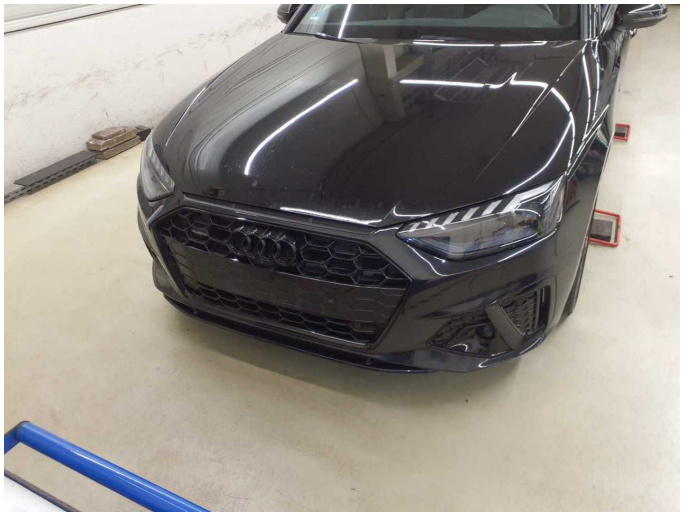
Damage 3: Front bumper: Front bumper (Lackablösung) - Paint defect - Repair and paint

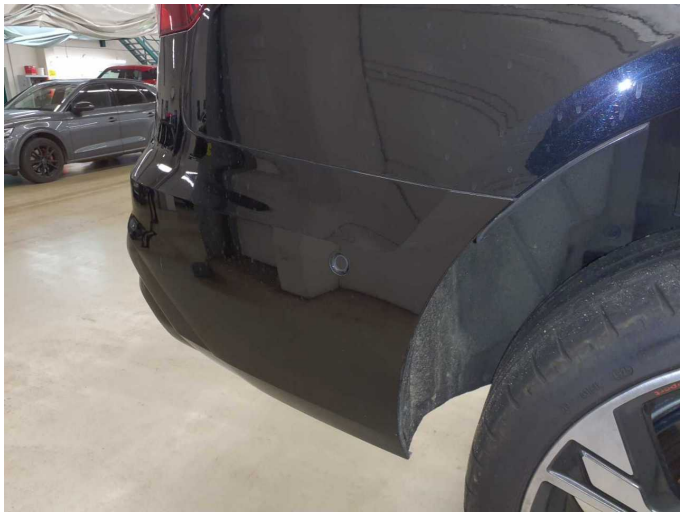
Wear and tear 1: Rear bumper: Rear bumper - Scratch(es) - No deduction
