Expertise

Protocol number: 48034344
Order No. / Reference: 27013813
Inspection date: 8 Oct 2026

Manufacturer: Mercedes-Benz	Model: GLB 220 d 4Matic 8G-DCT Progressive Advanced
VIN: W1N4M1FB3RW343182

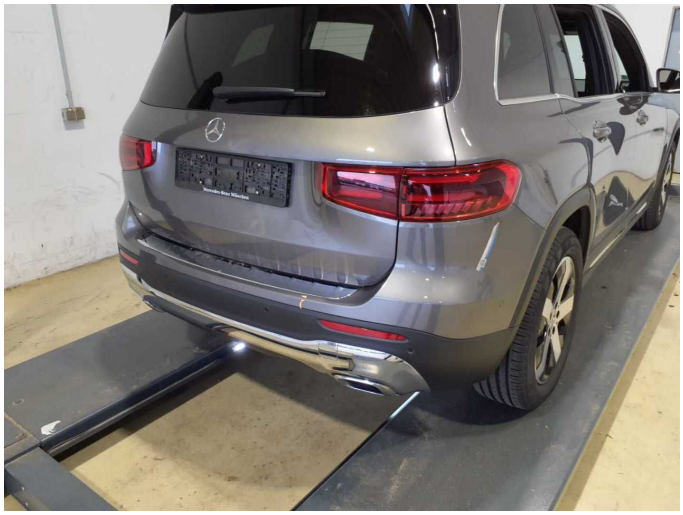
Damage 2: Door - rear right side: Door - dent(s) - Smooth repair work

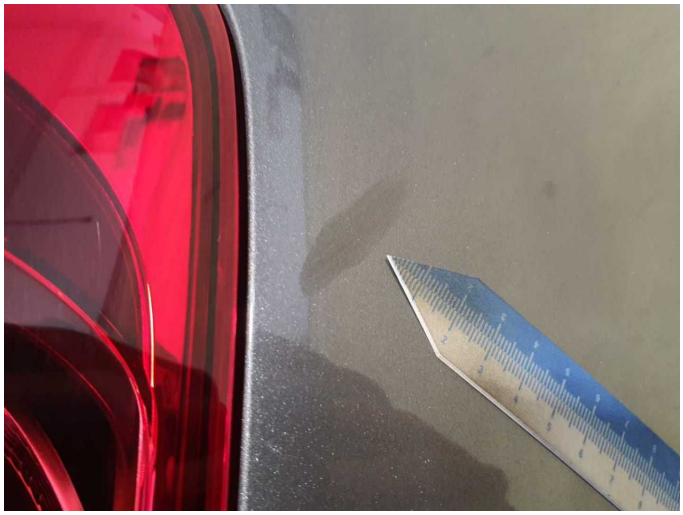
Damage 3: Rear bumper: Rear bumper - Scratch(es) - Paint
