Expertise

Protocol number: 48488944
Order No. / Reference: 27188811
Inspection date: 29 Oct 2026

Manufacturer: Polestar	Model: 2 Dual Motor 78kWh
VIN: YSMVSEDE8PL165018

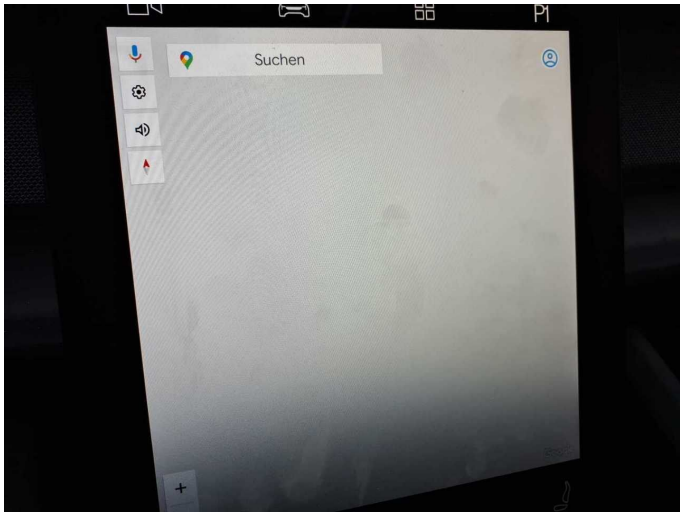
Figure 19: Navigation

Damage 3: Multimedia system: Navigation system - Non-operational - Perform diagnosis

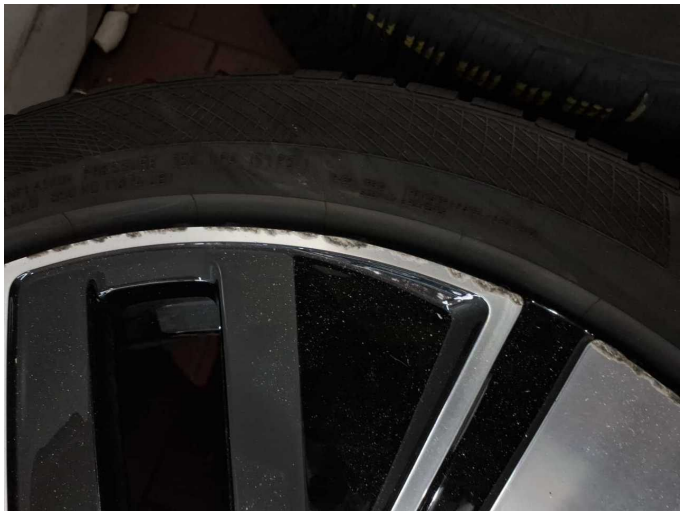
Damage 6: 2nd wheel set: 1 alloy rim (Großflächig mit Materialabtrag) - Scratched - Replace
