Expertise

Protocol number: 48404594
Order No. / Reference: 27216299
Inspection date: 28 Oct 2026

Manufacturer: Volkswagen	Model: Transporter T6.1 4MOTION Kurz
VIN: WV1ZZZ7HZMX016039

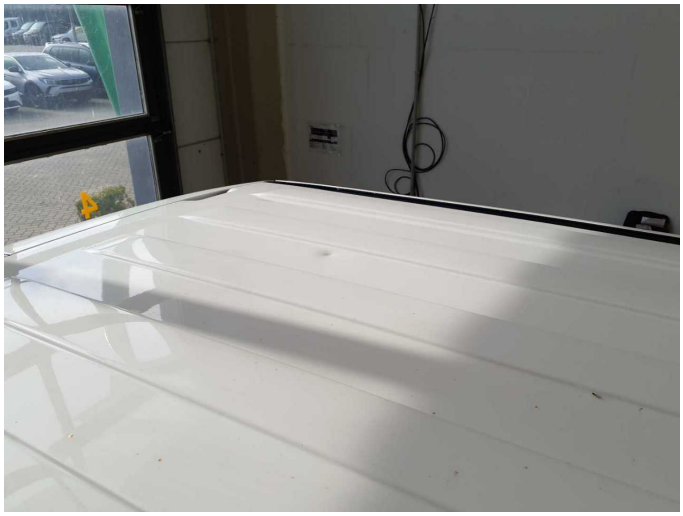
Damage 3: Roof: Roof - Dent / paintcoat damage - Smart repair
