Expertise

Protocol number: 48593445
Order No. / Reference: 27272213
Inspection date: 10 Nov 2026

Manufacturer: Hyundai	Model: TUCSON 1.6 T-GDi 48V-Hybrid 4WD DCT Trend
VIN: TMAJD81BHMJ097094

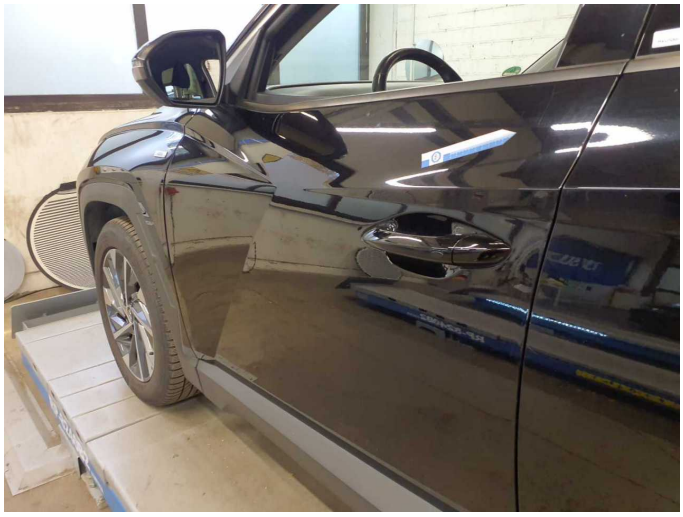
Damage 1: Equipment: Tirefit filler - Expired - Replace

Damage 2: Door - front left side: Door - Scratch(es) - Smart repair

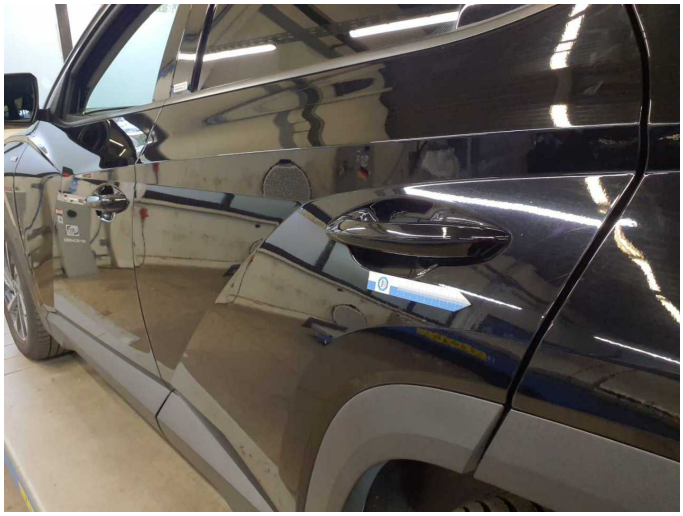
Damage 2: Door - front left side: Door - Scratch(es) - Smart repair

Damage 3: Door - rear left side: Door - Scratch(es) - Smart repair

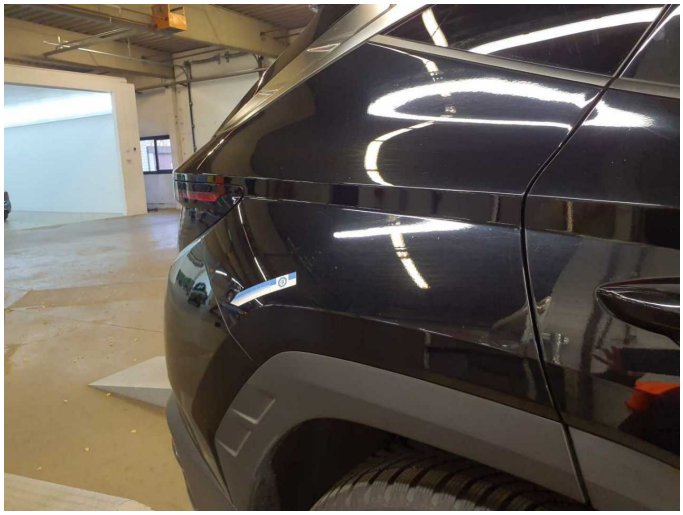
Damage 3: Door - rear left side: Door - Scratch(es) - Smart repair

Damage 4: Side panel - rear right side: Side panel - Scratch(es) - Paint

Damage 5: Door - rear right side: Door - Scratch(es) - Paint

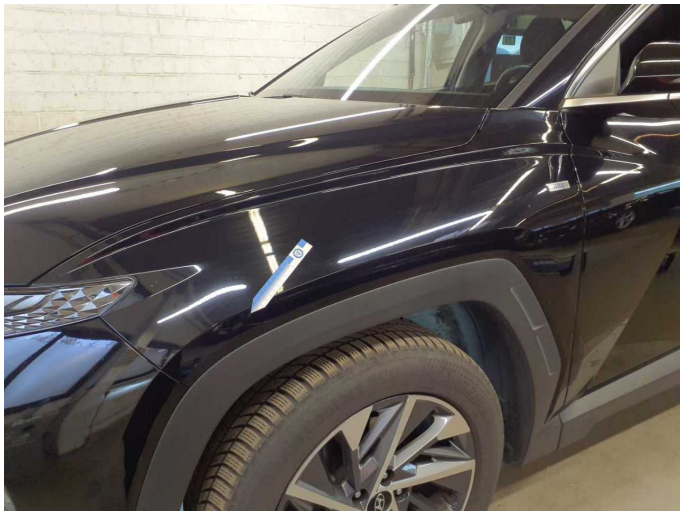
Damage 5: Door - rear right side: Door - Scratch(es) - Paint

Damage 6: Mudguard - left side: Mudguard - left side - Scratch(es) - Paint

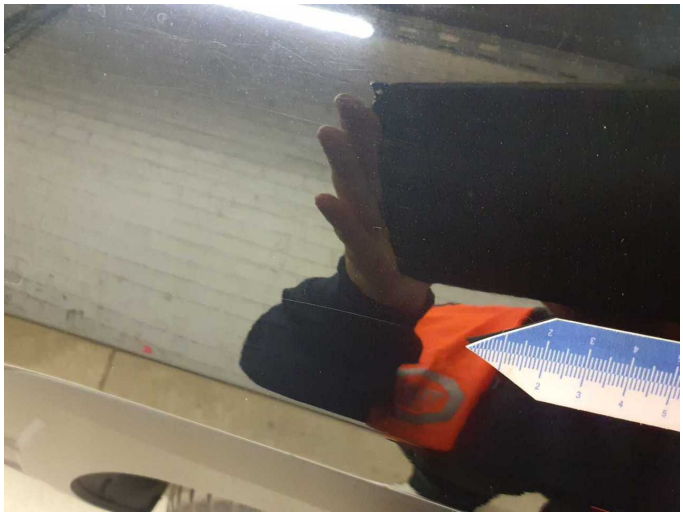
Damage 7: Mudguard - right side: Mudguard - right side - Dent / paintcoat damage - Paint
