BMW X1

Vehicle information

Summary of damages

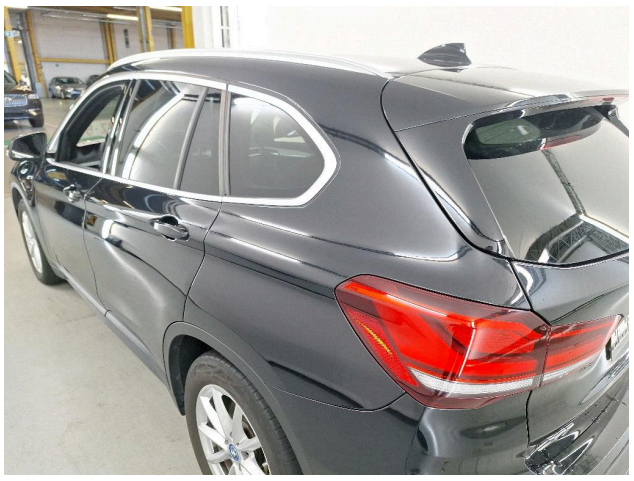
Left rear wing
repaired
. No repairs
.

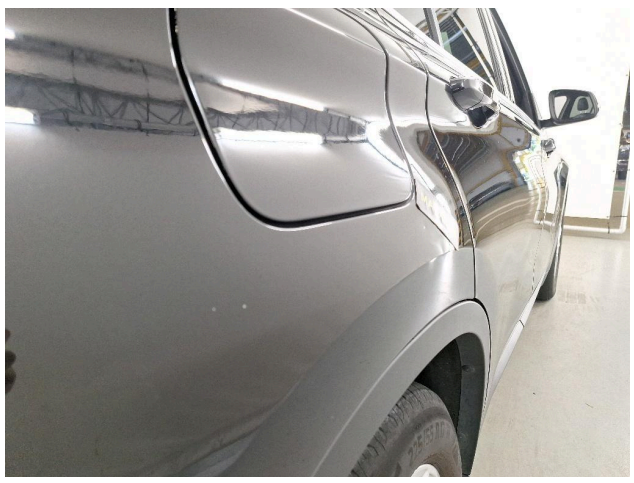
Bodywork
Damaged - Acceptable.
Roof & other

Ignition key
- Worn - Acceptable
- Interior

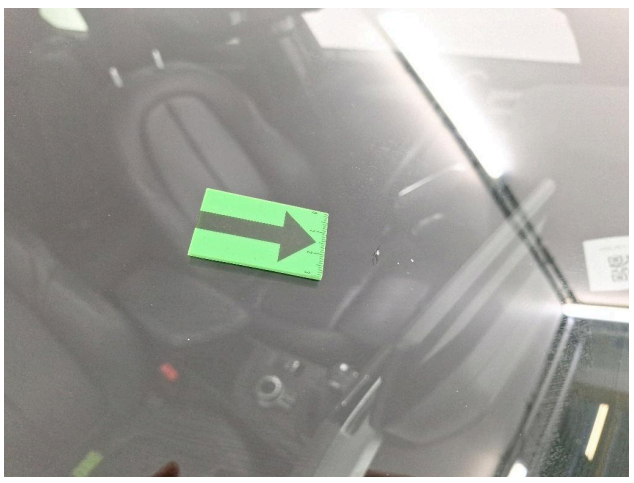
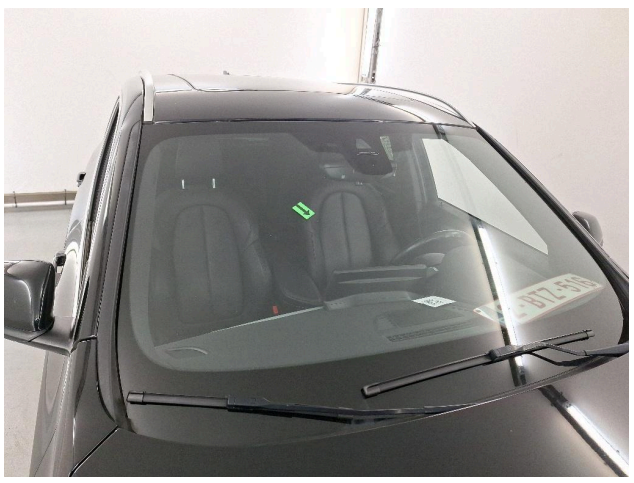
Damaged **Interior**
- Acceptable
Interior

Windshield Chip
(s)
Acceptable
Front

Front Right Tire
Worn
- Replace
Right

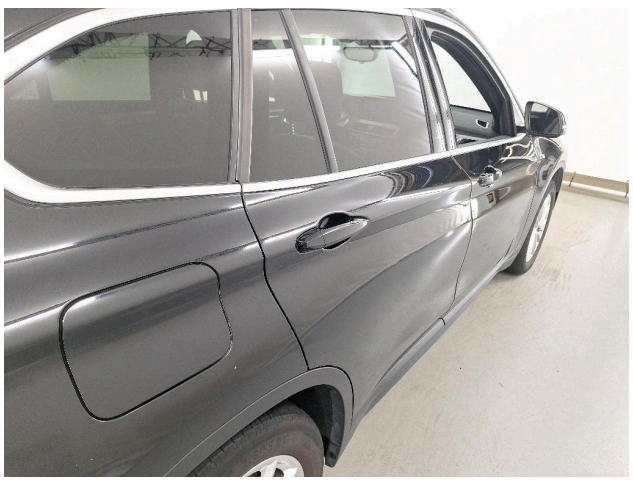
Right rear door
repaired.
No repairs
.

Left rear door repaired . No repairs .
