Expertise

Protocol number: 48509838
Order No. / Reference: 27247015
Inspection date: 3 Nov 2026

Manufacturer: Volkswagen	Model: Passat Variant 2.0 TDI SCR DSG Elegance
VIN: WVWZZZ3CZPE009058

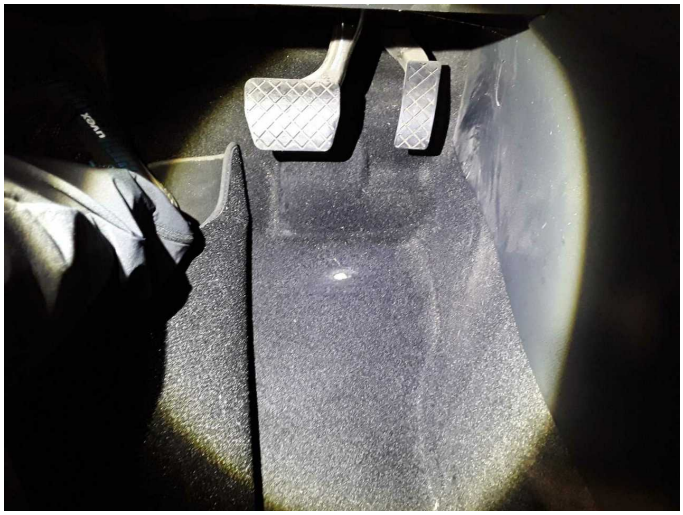
Damage 1: Trim / covers: Floor mats - Holes - Replace

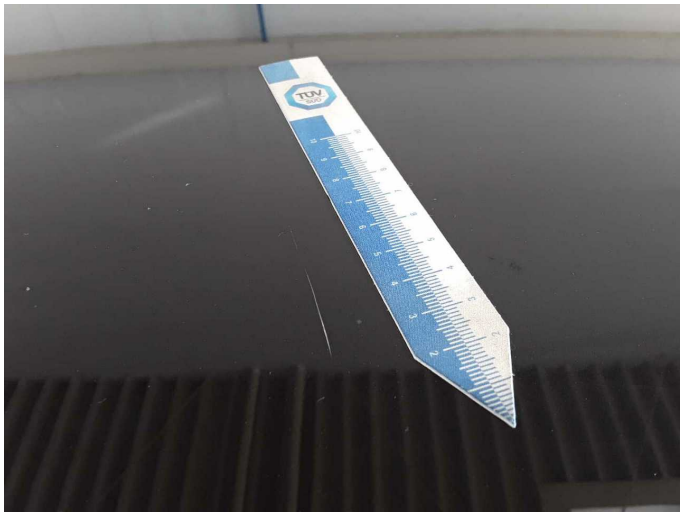
Damage 7: Roof: Roof - Scratch(es) - Paint
