Expertise

Protocol number: 47902213
Order No. / Reference: 27046366
Inspection date: 2 Oct 2026

Manufacturer: Skoda	Model: Octavia Combi 2.0 TDI Ambition
VIN: TMBJJ8NX1PY122884

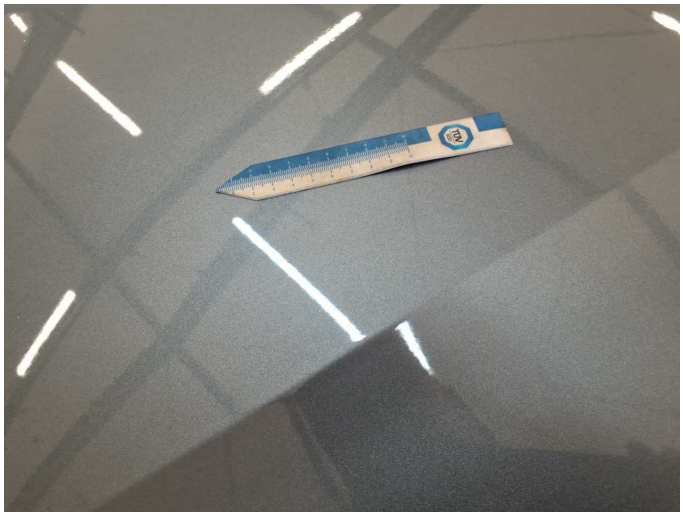
No.	Component group	Description
1	Bonnet	Bonnet (Schmutz unter klarlack inkl.Staubeinschlüsse und Mattstich) - Unprofessionally repaired - Paint

No.	Repainting
1	Bonnet, Unprofessionally carried out, Invoice of repair done Non-existent

- Das Fahrzeug befand sich zum Besichtigungszeitpunkt in nicht fachgerecht
reparierten Zustand. Schadenausweitung möglich, Zusatzkosten können entstehen.

Damage 1: Bonnet: Bonnet (Schmutz unter klarlack inkl.Staubeinschlüsse und Mattstich) - Unprofessionally repaired - Paint

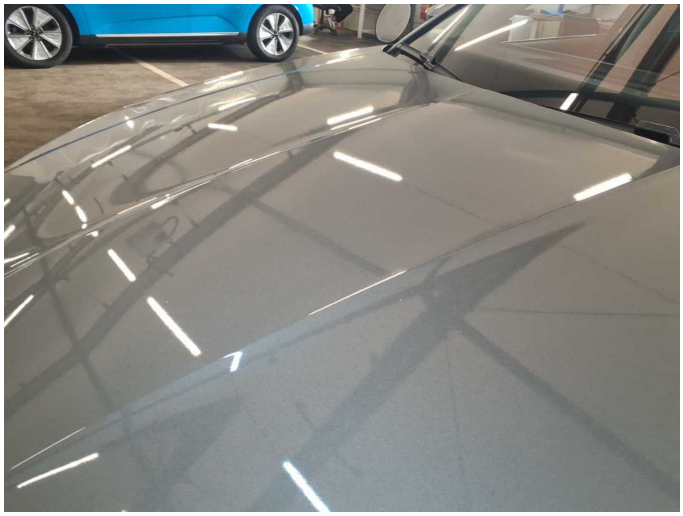
Damage 1: Bonnet: Bonnet (Schmutz unter klarlack inkl.Staubeinschlüsse und Mattstich) - Unprofessionally repaired - Paint

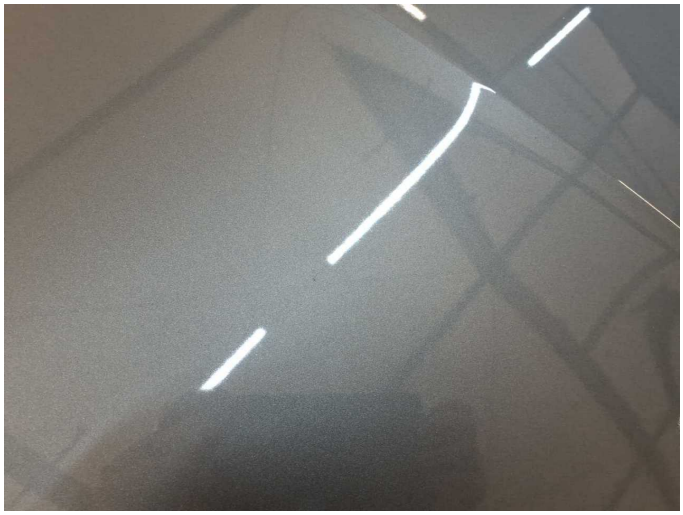
Damage 1: Bonnet: Bonnet (Schmutz unter klarlack inkl.Staubeinschlüsse und Mattstich) - Unprofessionally repaired - Paint

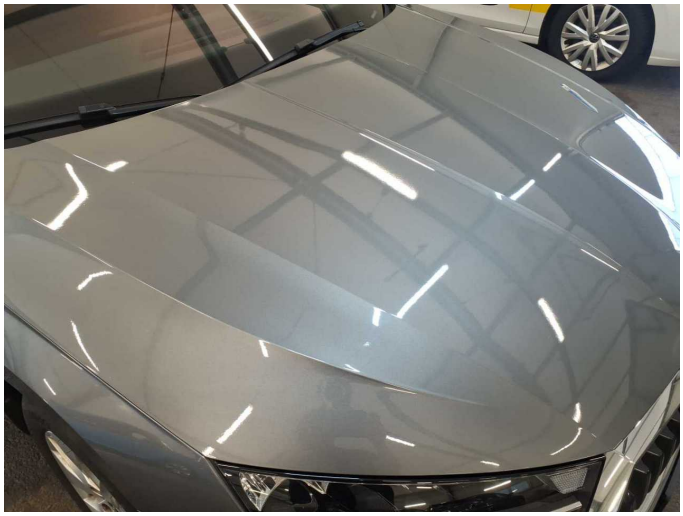
Damage 1: Bonnet: Bonnet (Schmutz unter klarlack inkl.Staubeinschlüsse und Mattstich) - Unprofessionally repaired - Paint

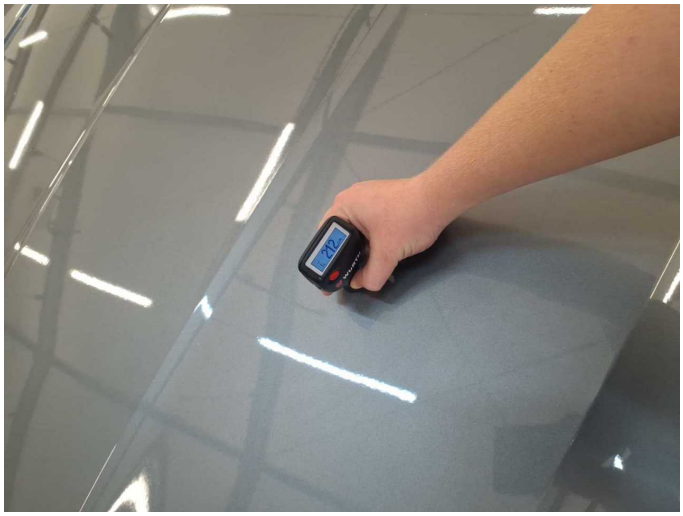
Damage 1: Bonnet: Bonnet (Schmutz unter klarlack inkl.Staubeinschlüsse und Mattstich) - Unprofessionally repaired - Paint

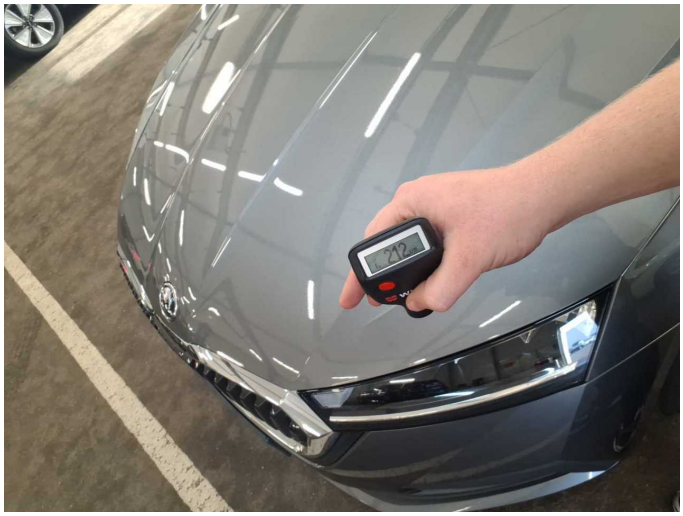
Repainting 1: Bonnet

Bonnet	212 µm
