Expertise

Protocol number: 48366412
Order No. / Reference: 27208586
Inspection date: 28 Oct 2026

Manufacturer: Mercedes-Benz	Model: GLC 300 e 4Matic 9G-TRONIC Avantgarde Advanced
VIN: W1NKM5GB6PF046868

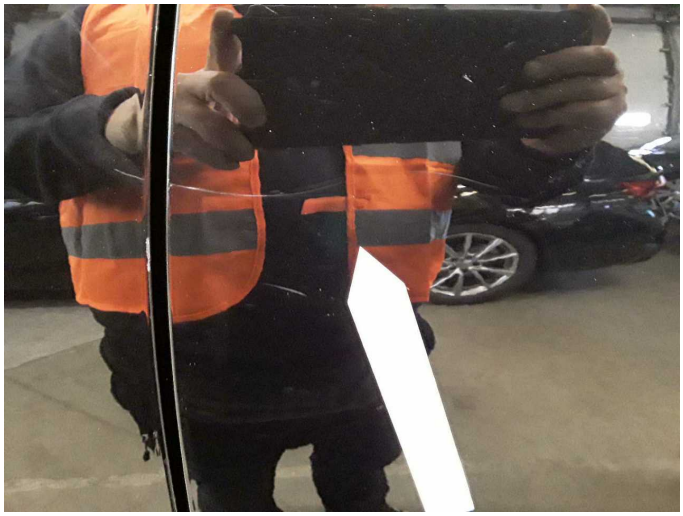
No.	Component group	Description
1	Door - rear left side	Door - Scratch(es) - Cover / polish
2	Side panel - rear right side	Sill - Dent / paintcoat damage - Smart repair
3	Door - front left side	Door edge - Scratch(es) - Smart repair
4	Misc.	Main inspection - Due - Perform
5	Wheel / tyres	Tyre - front right side (235 60 18 s) - Worn - Replace
6	Wheel / tyres	Alloy rim - front right side - Scratch(es) - Loss in value
7	Wheel / tyres	Alloy rim - rear right side - Scratch(es) - Loss in value
8	Misc.	Inspection / maintenance - Due - Perform
9	Door - rear right side	Door - Dent / paintcoat damage - Repair and paint
10	Bonnet	Bonnet (Vogelkot) - Scratch(es) - Paint

Damage 1: Door - rear left side: Door - Scratch(es) - Cover / polish

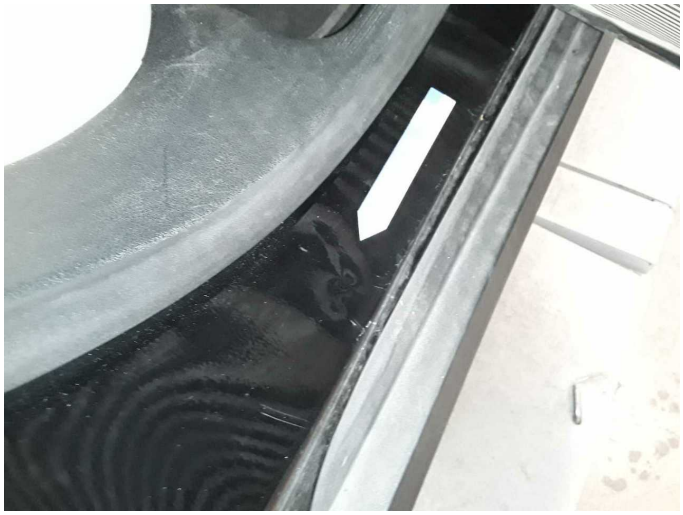
Damage 2: Side panel - rear right side: Sill - Dent / paintcoat damage - Smart repair

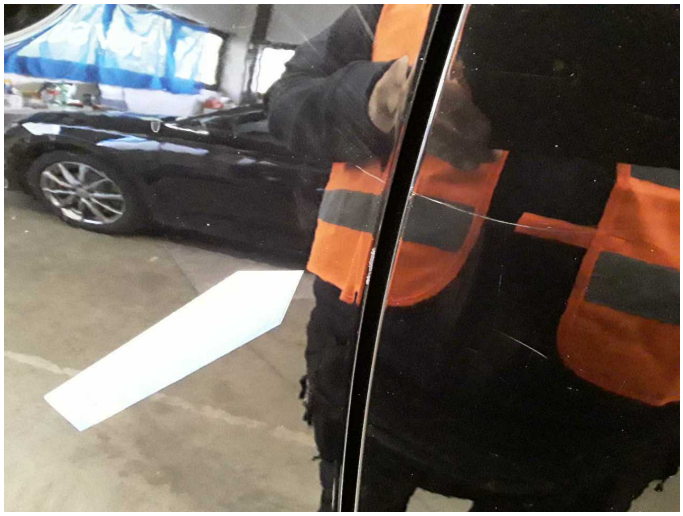
Damage 3: Door - front left side: Door edge - Scratch(es) - Smart repair

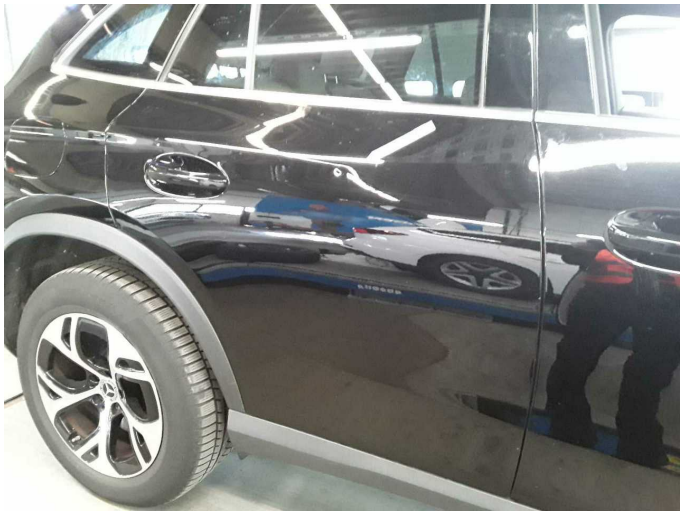
Damage 8: Misc.: Inspection / maintenance - Due - Perform

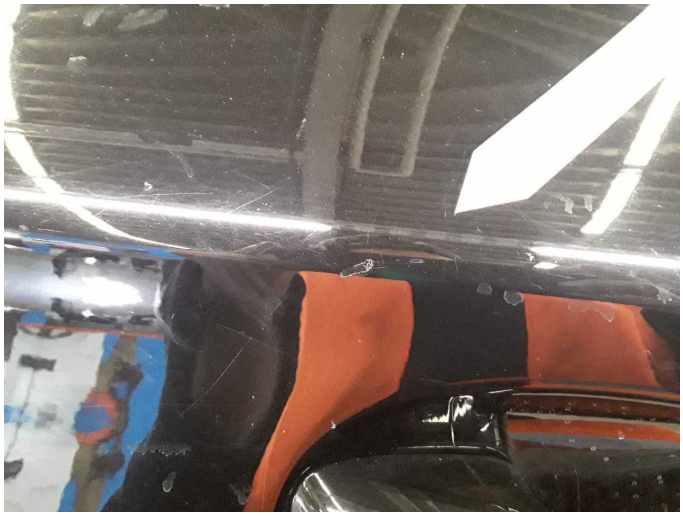
Damage 9: Door - rear right side: Door - Dent / paintcoat damage - Repair and paint

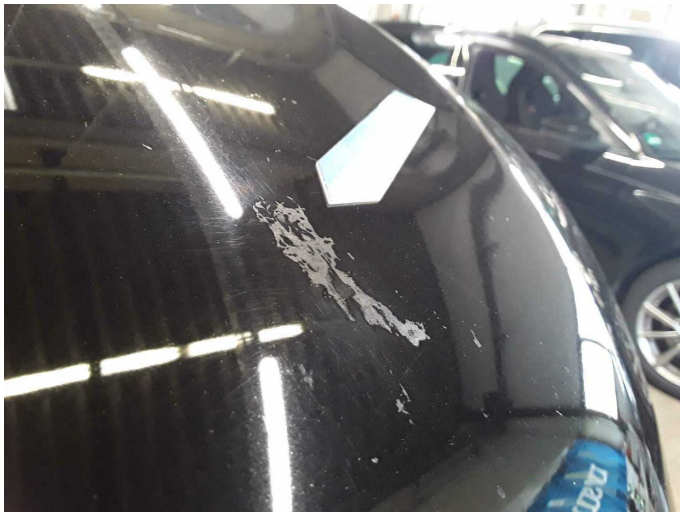
Damage 10: Bonnet: Bonnet (Vogelkot) - Scratch(es) - Paint
