APPRAISAL REPORT

Make:	BMW
Model / version:	X2
Vin:	WBAYN910605V55140
Plate:	2CFW589
Mileage:	62170
SOH:	
First registration:	08/07/2022
Color:	Saphirschwar

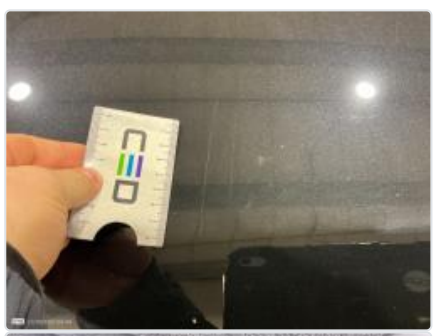
8 - Wing RR - Scratch(es)
