Expertise

Protocol number: 48211424
Order No. / Reference: 26995109
Inspection date: 15 Oct 2026

Manufacturer: Skoda	Model: Kodiaq 2.0 TDI 4x4 DSG Style
VIN: TMBLN7NS9P8060808

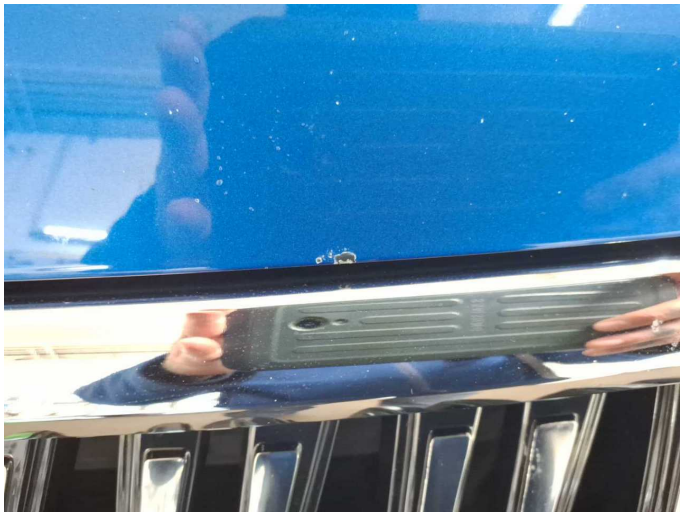
Damage 3: Bonnet: Bonnet (+ Korrosion) - Stone chips - Paint

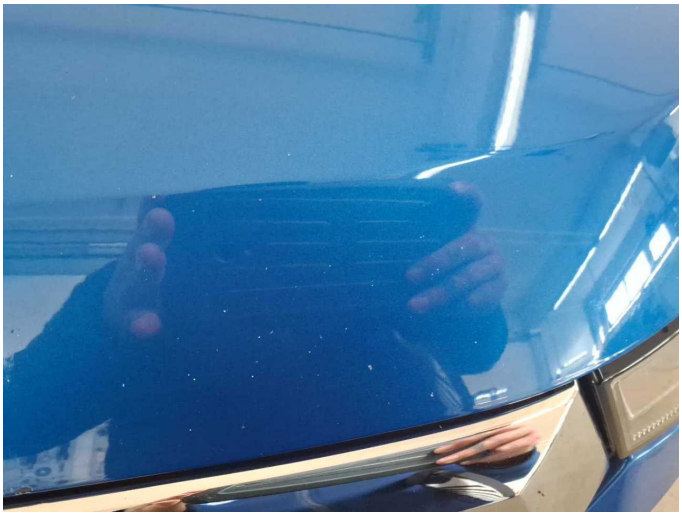
Damage 3: Bonnet: Bonnet (+ Korrosion) - Stone chips - Paint

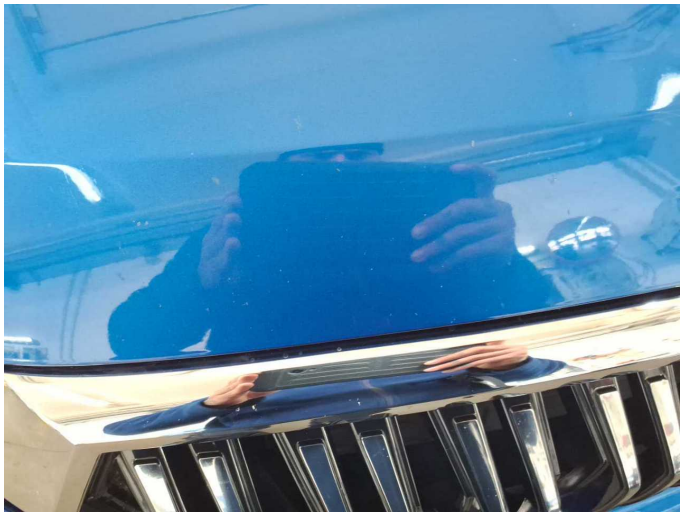
Damage 3: Bonnet: Bonnet (+ Korrosion) - Stone chips - Paint

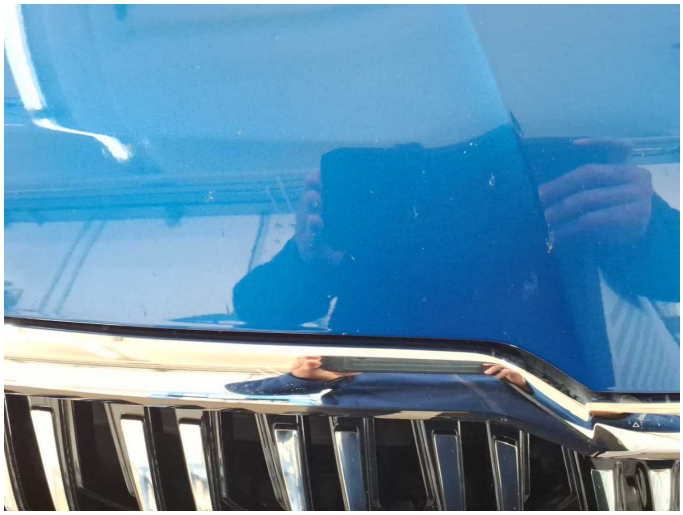
Damage 3: Bonnet: Bonnet (+ Korrosion) - Stone chips - Paint
