ARVAL
BNP PARIBAS GROUP

2DDK720

INSPECTION REPORT

End of contract

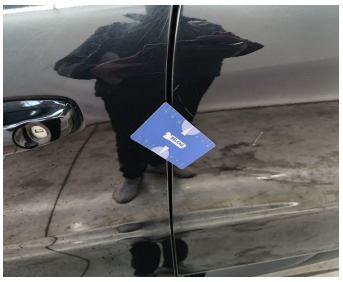
Door Front Right // Polish-scratch

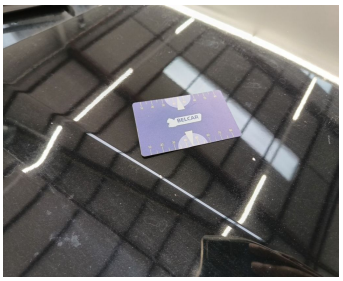
Door Rear Right // Smart Repair Small-dent
