AUDI A5 SPORTBACK

Vehicle information

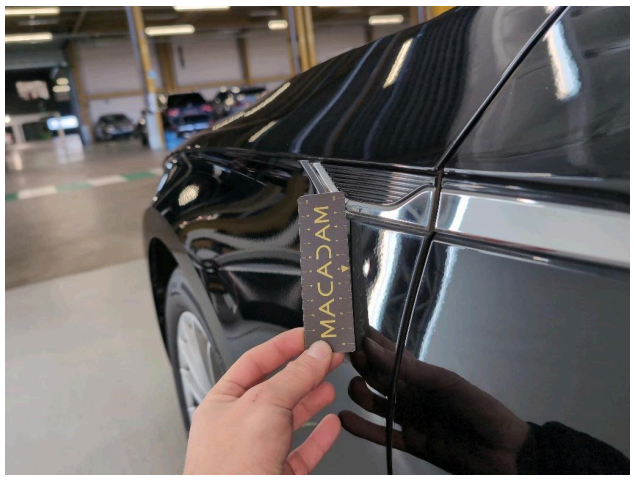
Bodywork

Damaged

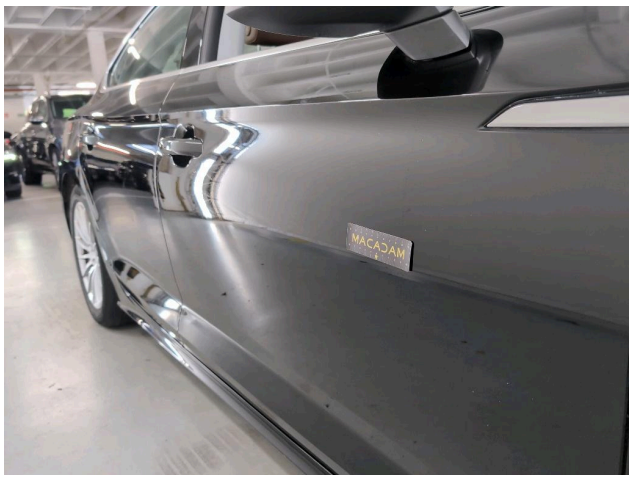
Door FR
Repaired
Acceptable
Right

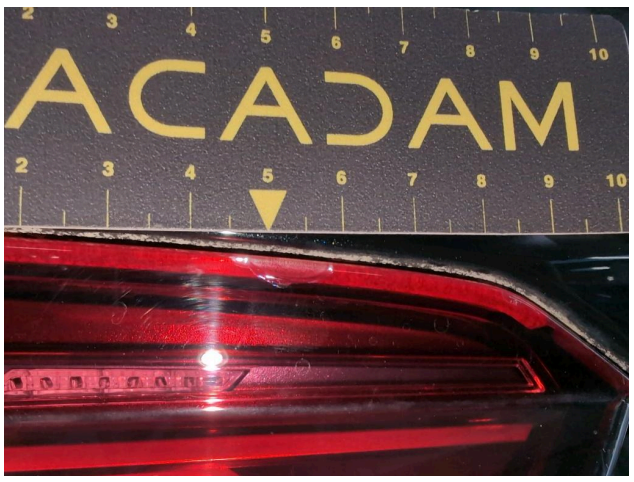
Rear light L
Crack
Replace
Rear
