# TESLA MODEL Y

## Vehicle information

## Summary of damages

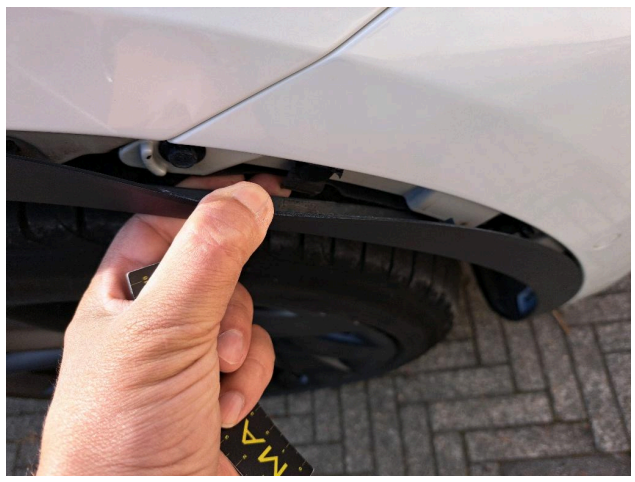
**Alloy wheel AVD**
Scratch(es)
LI - Repair and paint (complete)
Right

**Alloy wheel AVG**
Scratch(es)
LI - Repair and paint (complete)
Left
