Expertise

Protocol number: 48196669
Order No. / Reference: 27097395
Inspection date: 16 Oct 2026

Manufacturer: Mercedes-Benz	Model: C 200 d 9G-TRONIC
VIN: W1KAF0DB9PR136217

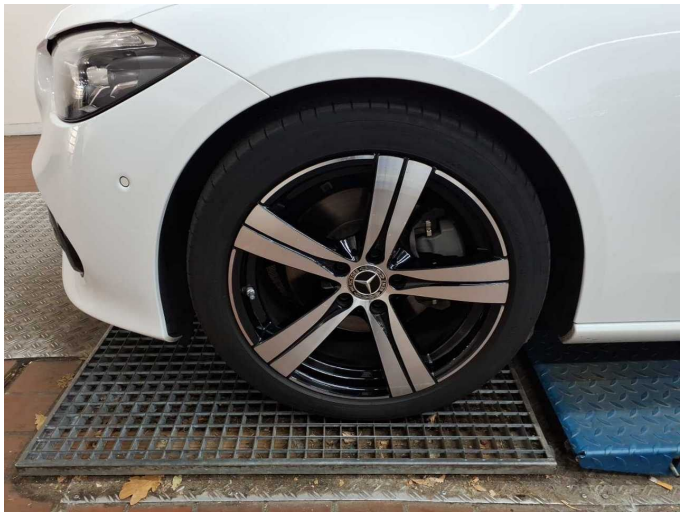
Damage 1: Wheel / tyres: Alloy rim - front right side - Scratch(es) - Loss in value
