Expertise

Protocol number: 48417617
Order No. / Reference: 27182697
Inspection date: 29 Oct 2026

Manufacturer: Volkswagen	Model: Passat Variant 2.0 TDI SCR Business
VIN: WVWZZZ3CZPE043678

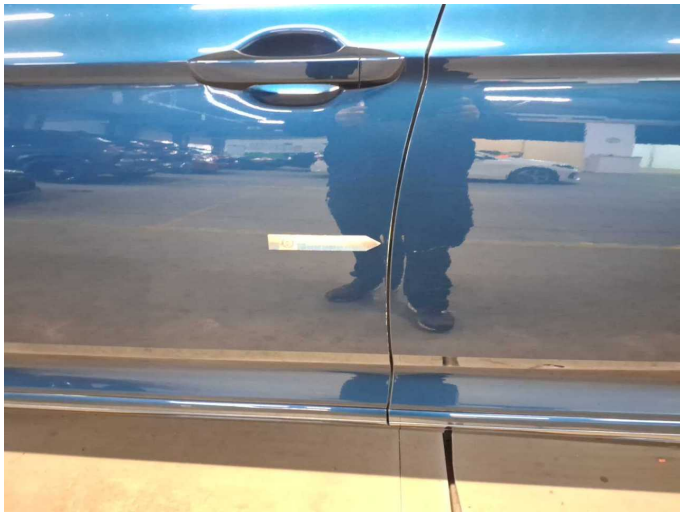
Damage 4: Door - rear right side: Door - Scratched - Smart repair

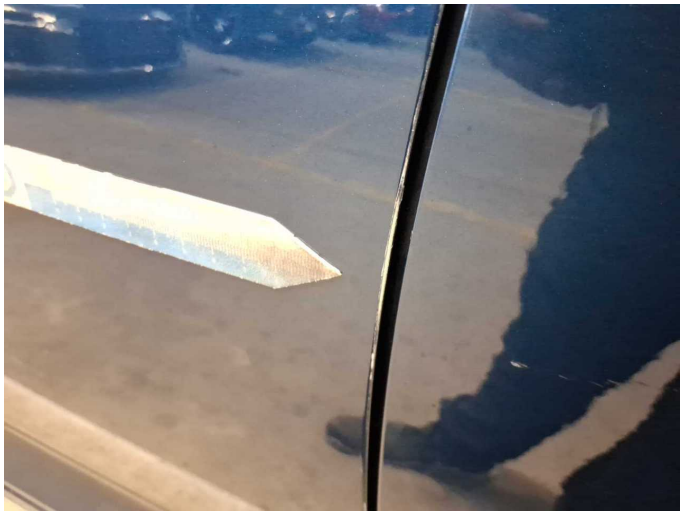
Damage 5: Door - front left side: Door edge - Scratched - Smart repair

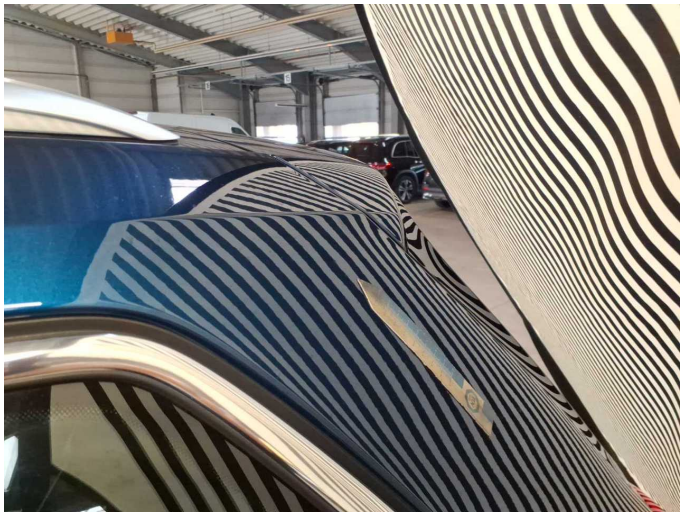
Damage 6: Side panel - rear left side: Side panel - dent(s) - Smooth repair work

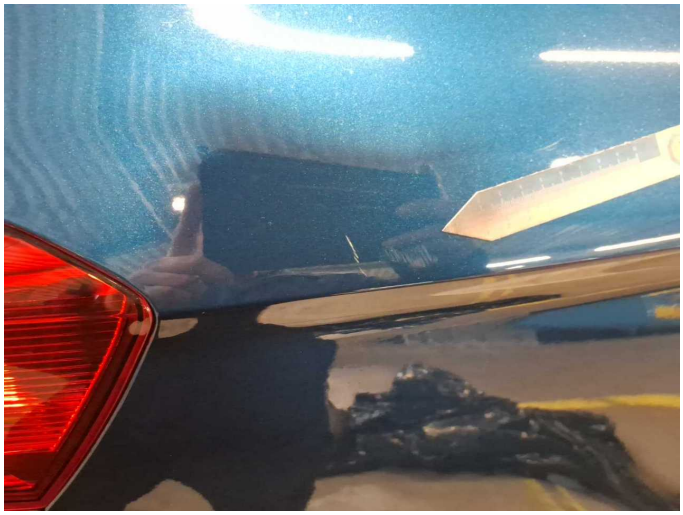
Damage 8: Side panel - rear right side: Side panel - Scratched - Smart repair

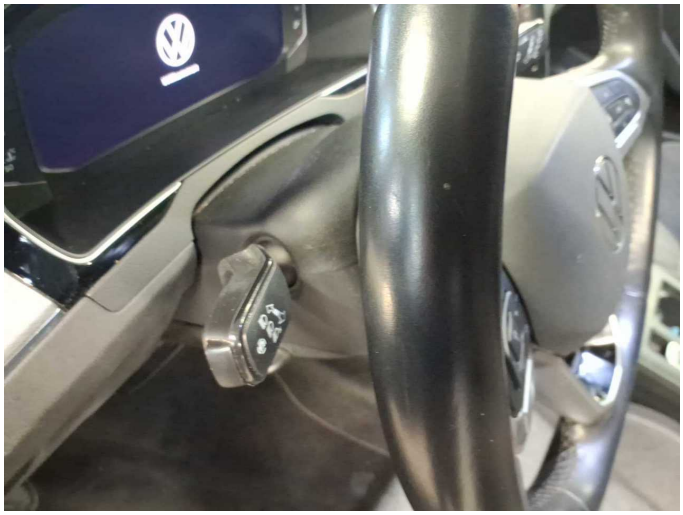
Damage 10: Steering system: Steering wheel - Scratched - Smart repair

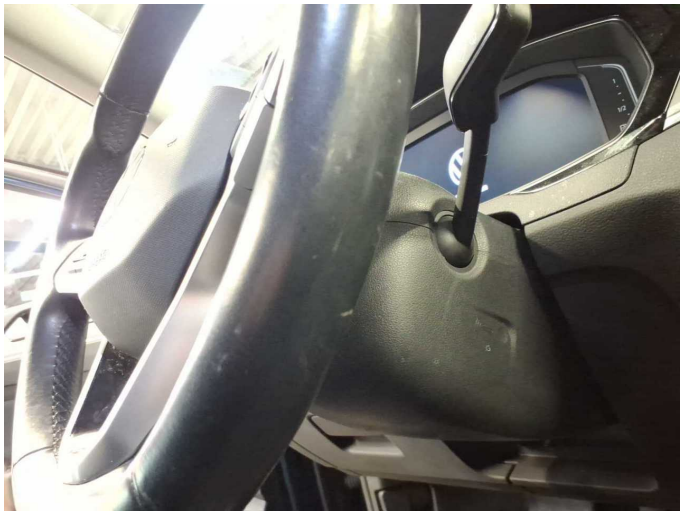
Damage 10: Steering system: Steering wheel - Scratched - Smart repair

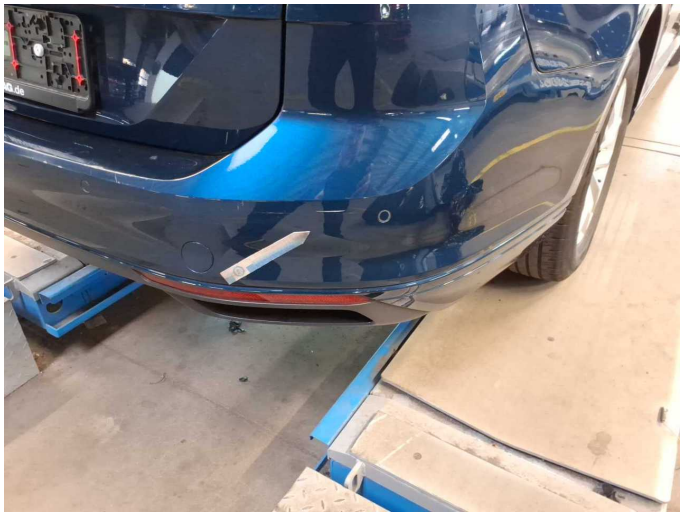
Damage 12: Rear bumper: Rear bumper - Scratched - Repair and paint

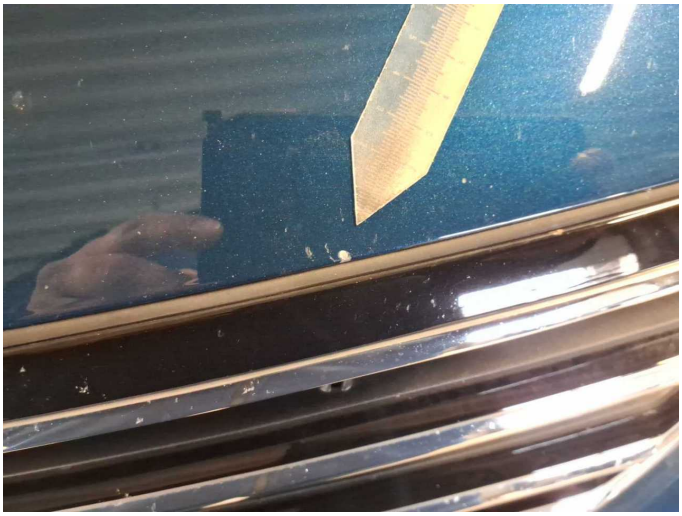
Wear and tear 4: Bonnet: Bonnet - Stone chips - No deduction
