TÜV SÜD Auto Partner GmbH
Wiesenring 2
04159 Leipzig

Expertise

Protocol number: 48361802
Order No. / Reference: 27080659
Inspection date: 28 Oct 2026

Manufacturer: Opel	Model: Vivaro 2.0 D Cargo L EHZ Autm. Edition Kasten
VIN: VXEVFEHS7N7033541

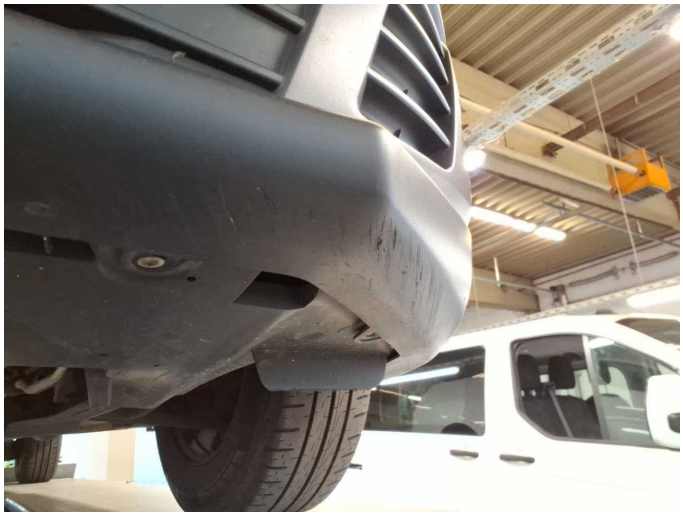
Damage 7: Front bumper: Front bumper (unpainted) - Scratch(es) - Loss in value
