Expertise

Protocol number: 47322960
Order No. / Reference: 26470054
Inspection date: 31 Aug 2026

Manufacturer: Mercedes-Benz	Model: GLB 200 d 4Matic 8G-DCT
VIN: W1N4M1DB8PW281598

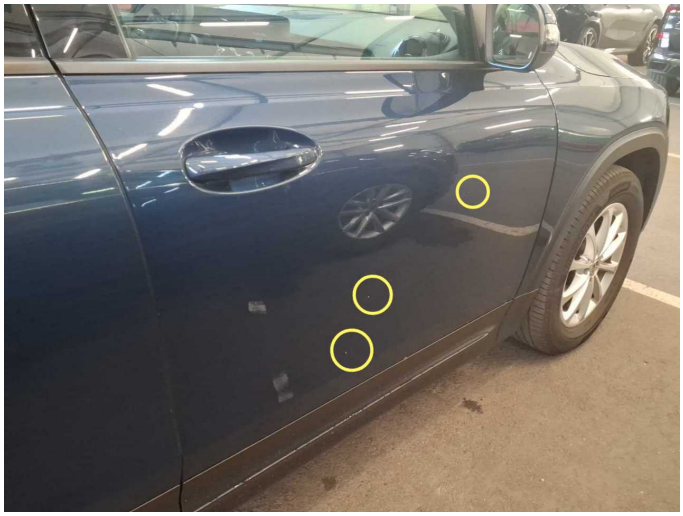
Damage 5: Door - front left side: Door - Scratch(es) - Paint
