Expertise

Protocol number: 48559712
Order No. / Reference: 27268054
Inspection date: 6 Nov 2026

Manufacturer: Skoda	Model: Octavia Combi 2.0 TDI DSG Sportline
VIN: TMBJJ8NX2PY098174

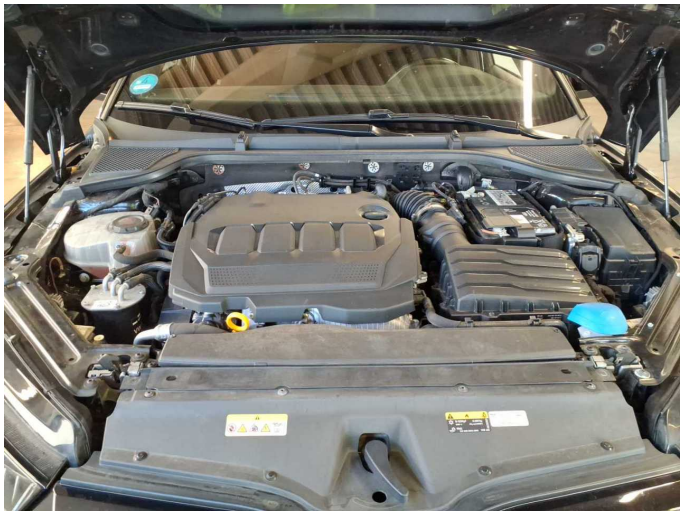
Figure 21: Misc.

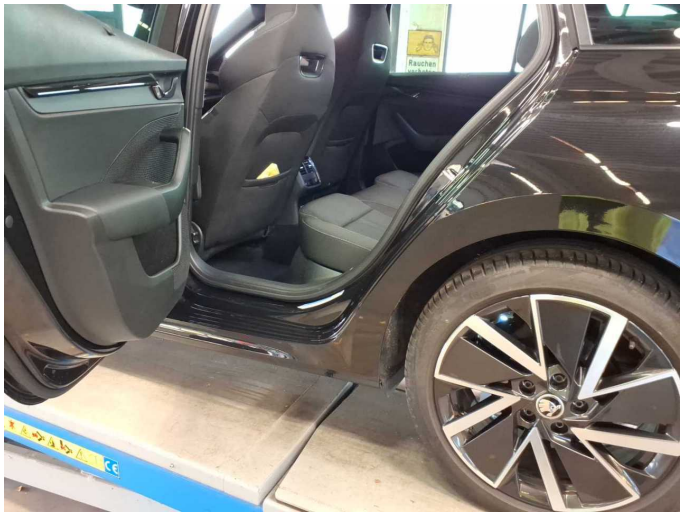
Damage 2: Side panel - rear right side: Side panel - Dent / paintcoat damage - Smart repair
