Expertise

Protocol number: 47982926
Order No. / Reference: 26840667
Inspection date: 6 Oct 2026

Manufacturer: Mercedes-Benz	Model: C 200 d T 9G-TRONIC Avantgarde
VIN: W1KAH0DB8PF124930

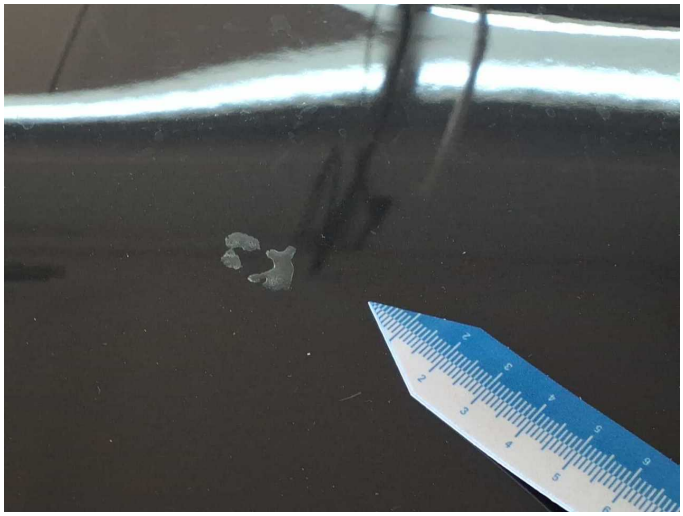
Damage 2: Bonnet: Bonnet (Harz) - Soiled - Conditioning

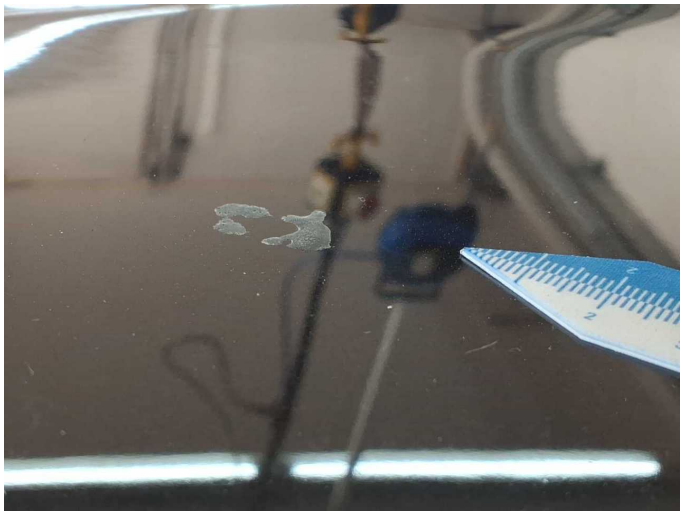
Damage 2: Bonnet: Bonnet (Harz) - Soiled - Conditioning

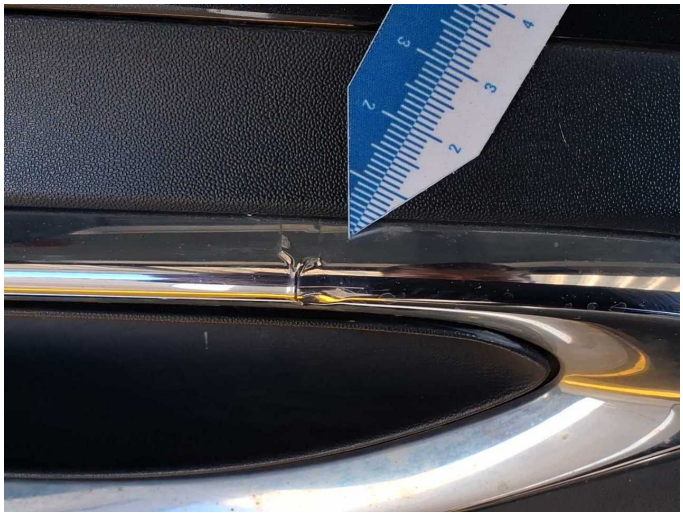
Damage 9: Rear bumper: Spoiler (Zierleiste) - Broken / torn - Replace

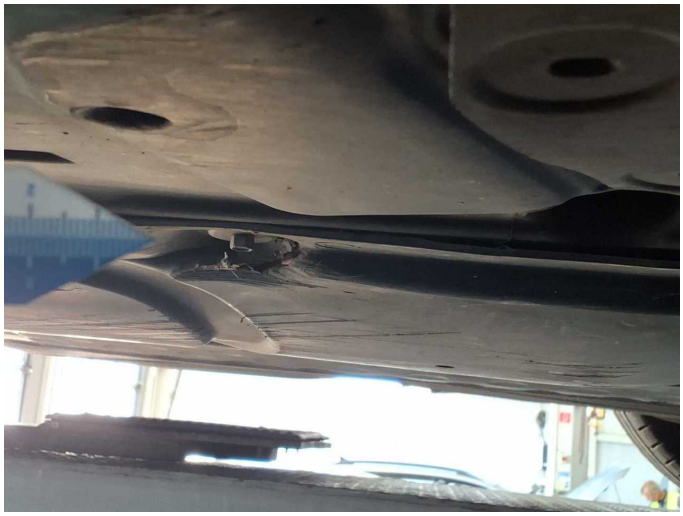
Damage 9: Rear bumper: Spoiler (Zierleiste) - Broken / torn - Replace
