Expertise

Protocol number: 48382606
Order No. / Reference: 27170944
Inspection date: 26 Oct 2026

Manufacturer: Mercedes-Benz	Model: C 200 d 9G-TRONIC Avantgarde
VIN: W1KAF0DB0PR143265

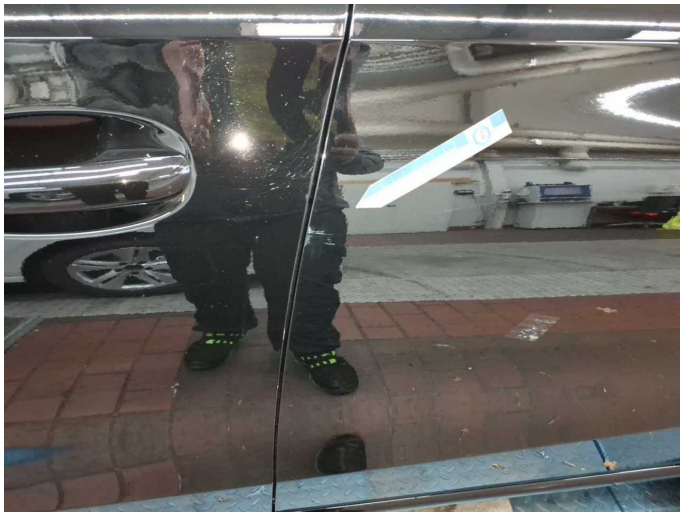
No.	Component group	Description
1	Door - rear left side	Door - Scratch(es) - Paint
2	Rear bumper	Rear bumper - Scratched - Paint
3	Vehicle glazing	Windscreen - Stone chips - Replace

Damage 1: Door - rear left side: Door - Scratch(es) - Paint

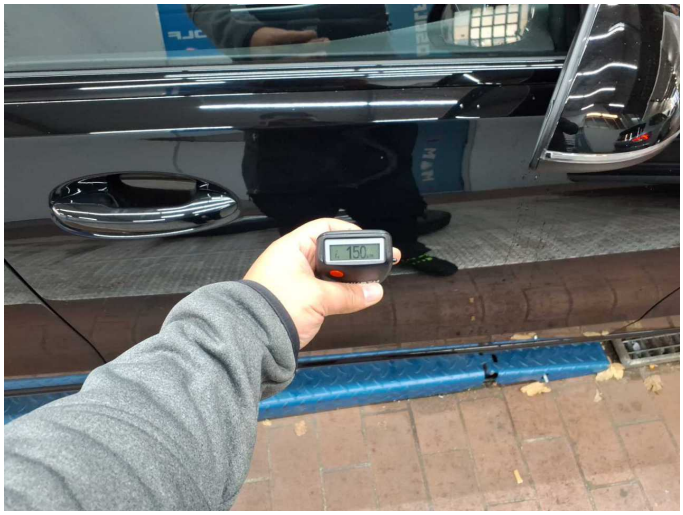
No.	Component group	Description
1	Misc.	Main inspection - No evidence - No deduction
2	Bonnet	Bonnet - Stone chips - No deduction
3	Front bumper	Front bumper - Stone chips - No deduction
4	Door - front left side	Door - dent(s) - No deduction

Wear and tear 4: Door - front left side: Door - dent(s) - No deduction
