TÜV SÜD Auto Partner GmbH
Wiesenring 2
04159 Leipzig

Expertise

Protocol number: 48447868
Order No. / Reference: 27249255
Inspection date: 27 Oct 2026

Manufacturer: Opel	Model: Corsa 1.5 Diesel Start/Stop Elegance
VIN: VXKUBYHTKP4123511

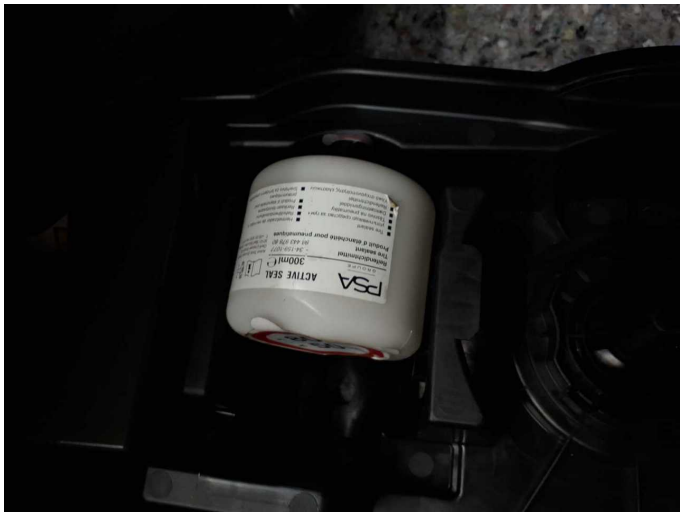
No.	Component group	Description
1	Equipment	Tirefit filler - Empty - Replace
2	Side panel - rear right side	Side panel - dent(s) - Smart repair

Damage 1: Equipment: Tirefit filler - Empty - Replace

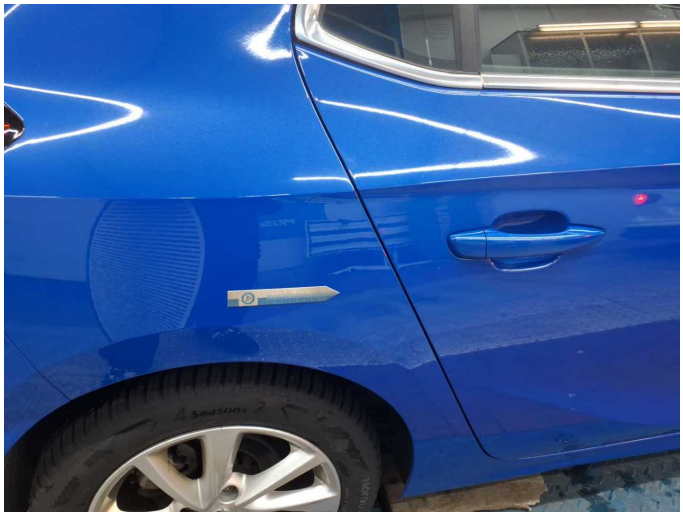
Damage 2: Side panel - rear right side: Side panel - dent(s) - Smart repair

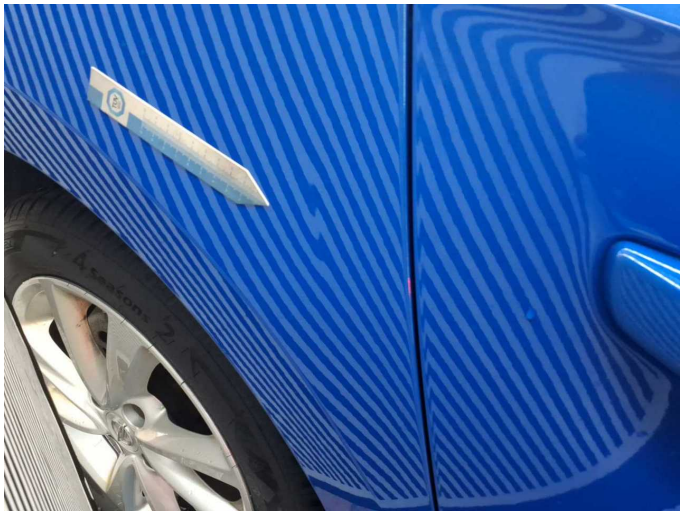
Damage 2: Side panel - rear right side: Side panel - dent(s) - Smart repair
