Expertise

Protocol number: 48586188
Order No. / Reference: 27211701
Inspection date: 9 Nov 2026

Manufacturer: Ford	Model: Puma 1.0 EcoBoost Hybrid Aut. TITANIUM
VIN: WF02XXERK2PL28631

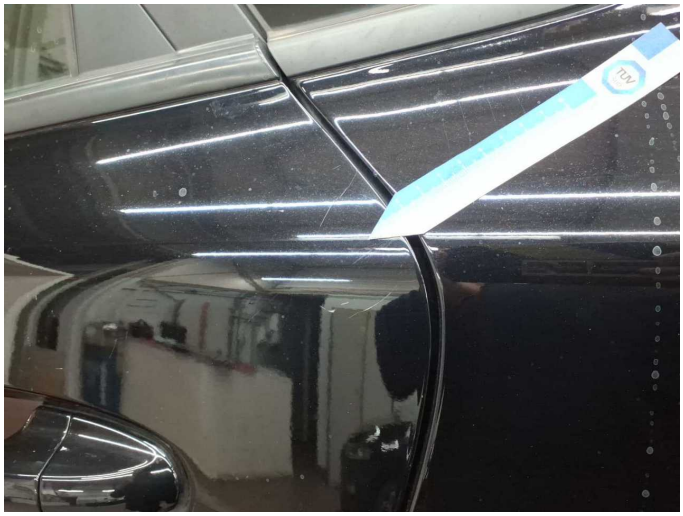
Damage 6: Door - rear left side: Door - Scratch(es) - Paint
