MACADAM
Volvo XC40 '17

Vehicle information

Damage summary

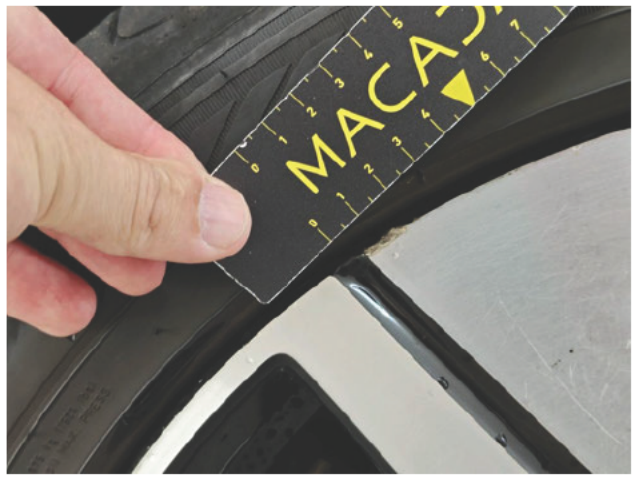
Alloy rim FL
Scratch(es)
Repair and paint (complete)
Left

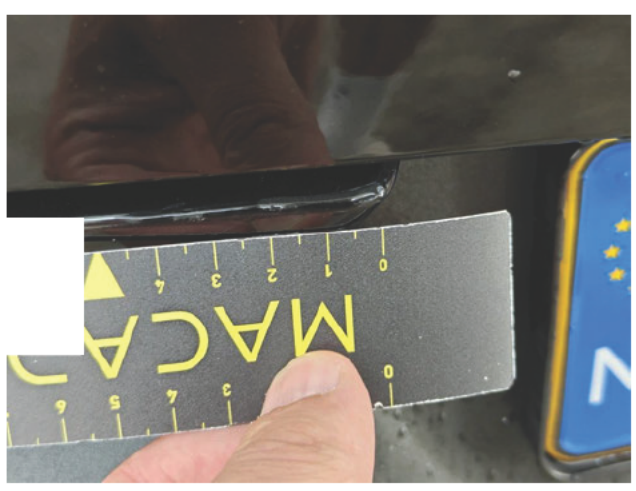
Bumper corner RL
Scratch(es)
Repair and paint (complete)
Rear
