AUDI Q5 (FYG)(06.2020->) 35 TDI BASE HYBRIDATION LÉGÈRE 120 KW (MOTEUR 2,0 LITRE(S) - 120 KW 16V TDI) 4 PORTES

VIN: WAUZZZFY6P2005424

Inspection loc	Statement date	Inspection approval date
PARC HÖDLMAYR TONGEREN	15/10/2026	16/10/2026

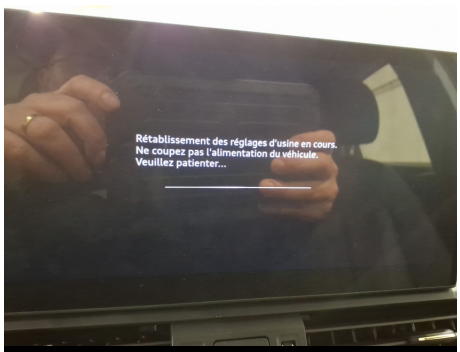
Personal Data / - / Non Compliant

#	Element	Defect	Correction
001	Personal Data / -	Non Compliant	Carry out

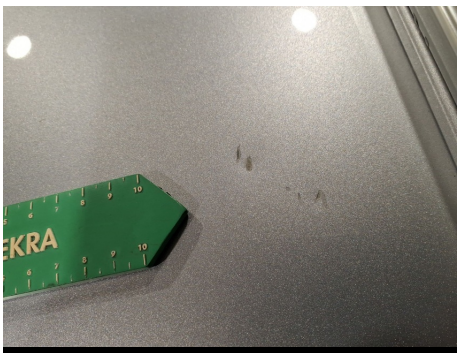
003	Roof / - Sunroof : No	Dent	Repair

Roof / - / Dent
