Expertise

Protocol number: 48226063
Order No. / Reference: 27100194
Inspection date: 13 Oct 2026

Manufacturer: Volkswagen	Model: Golf 1.4 eHybrid OPF DSG Style
VIN: WVWZZZCD8PW303213

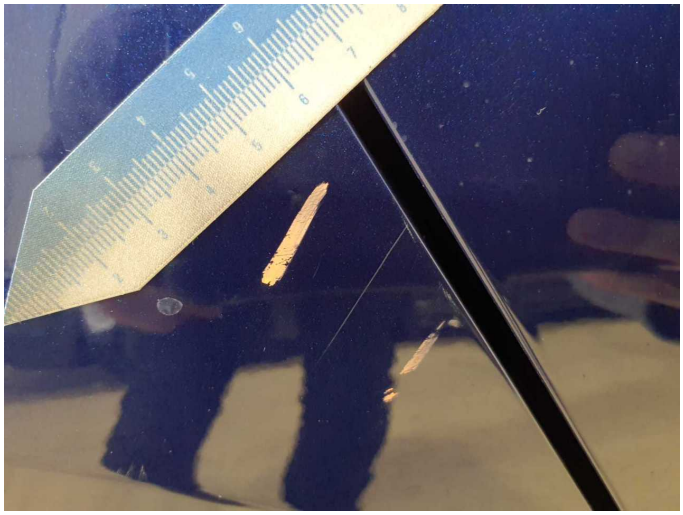
Damage 3: Side panel - rear right side: Side panel - Dent / paintcoat damage - Smart repair

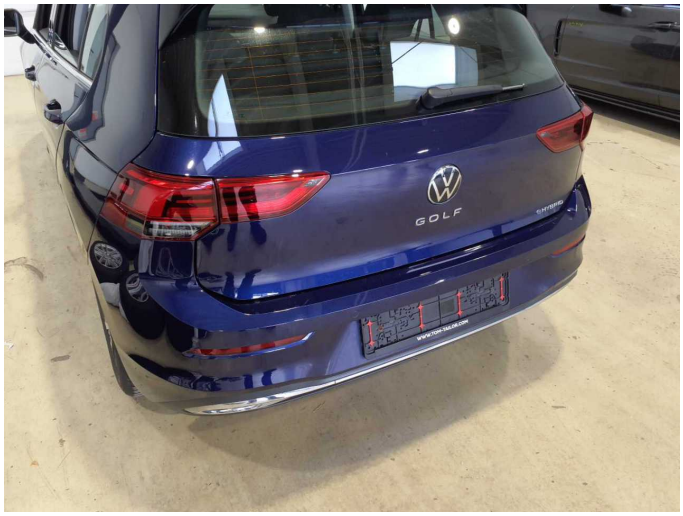
Damage 3: Side panel - rear right side: Side panel - Dent / paintcoat damage - Smart repair

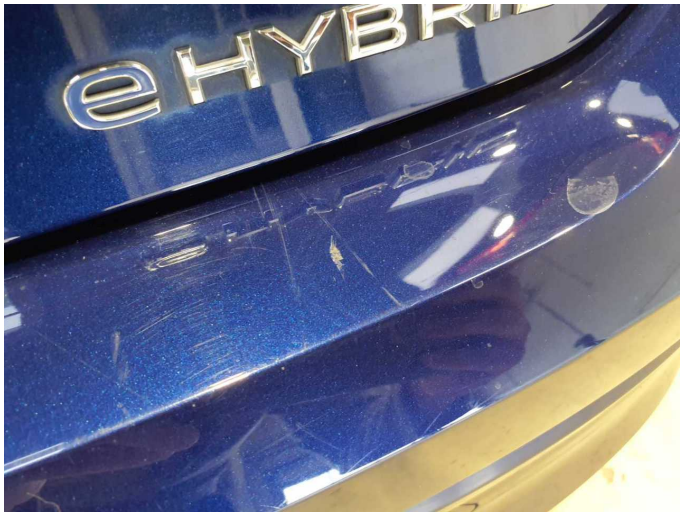
Damage 4: Rear bumper: Rear bumper - Scratch(es) - Smart repair

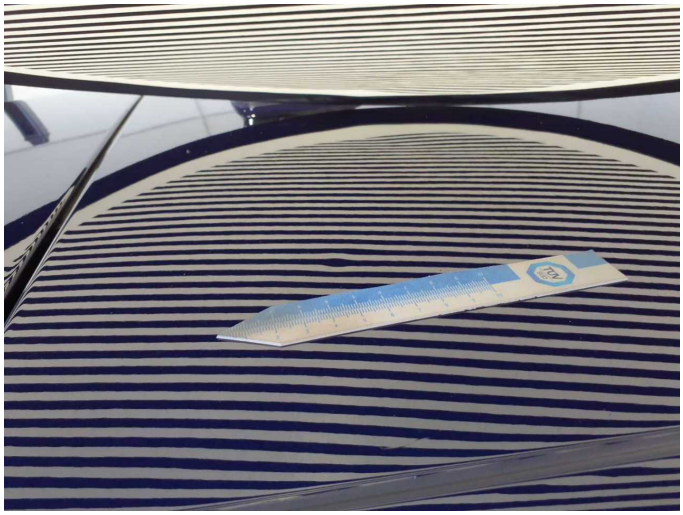
Damage 5: Door - rear left side: Door - Scratch(es) - Smart repair

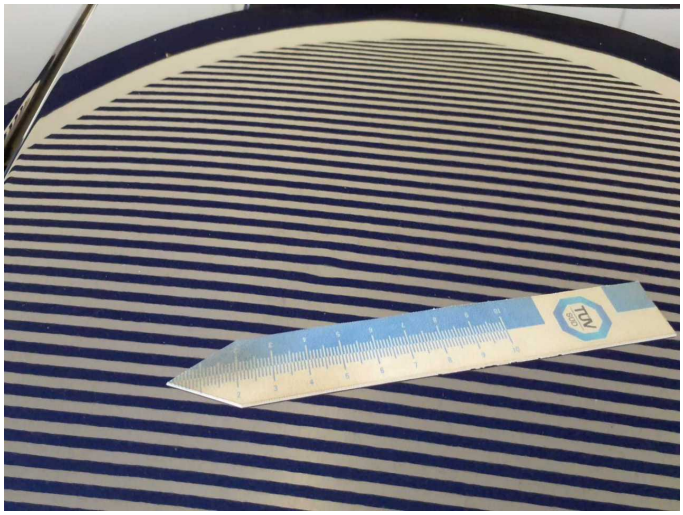
Damage 6: Roof: Roof - dent(s) - Smooth repair work
