Expertise

Protocol number: 48413756
Order No. / Reference: 26968353
Inspection date: 20 Oct 2026

Manufacturer: Skoda	Model: Octavia Combi 2.0 TDI Ambition
VIN: TMBJG7NX7MY174640

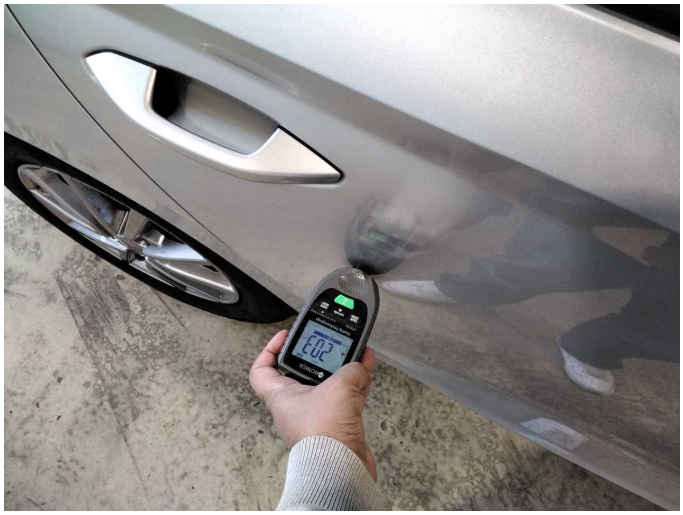
Side panel - rear right side	300 µm	Door - rear right side	203 µm

Repainting 1: Side panel - rear right side
