Expertise

Protocol number: 48006518
Order No. / Reference: 26879481
Inspection date: 8 Oct 2026

Manufacturer: Seat	Model: Alhambra 1.4 TSI S&S OPF STYLE
VIN: VSSZZZ7NZNV500938

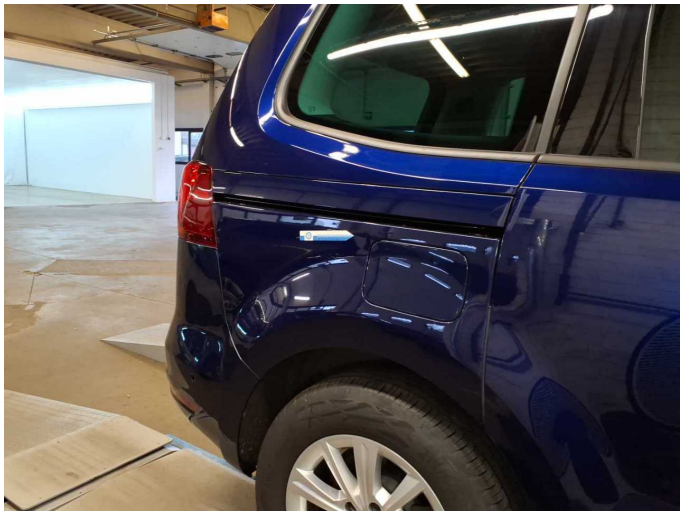
Figure 33: Misc.

Damage 1: Side panel - rear right side: Side panel - dent(s) - Smooth repair work

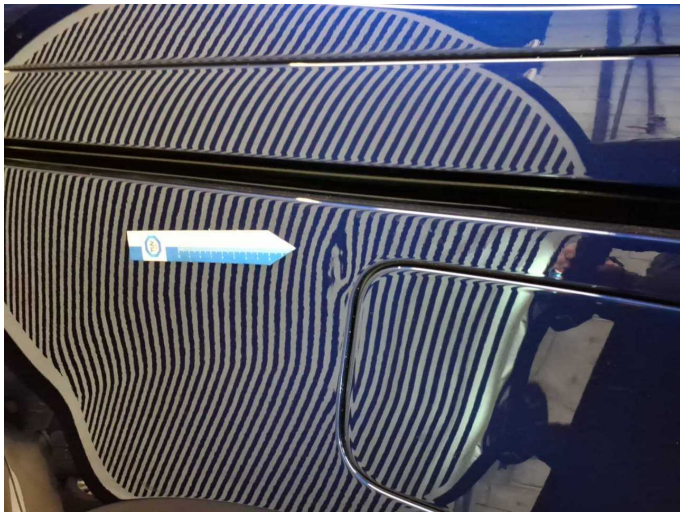
Damage 1: Side panel - rear right side: Side panel - dent(s) - Smooth repair work

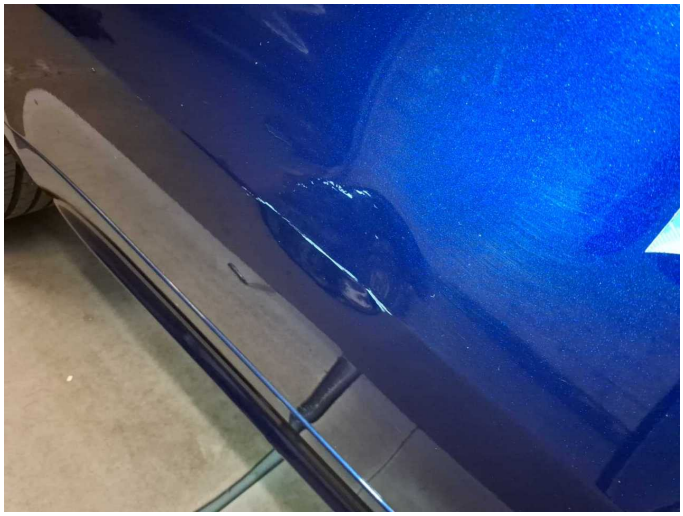
Damage 4: Door - rear right side: Door - Dent / paintcoat damage - Repair and paint
