MACADAM

Citroen C4: R504RG

Vinnumber:	**VR7BCZKXCNE057433**	Versionname:	**e-C4 100kW/50kWh Feel Pack automaat**
First Registrationdate:	**31/10/2022**	Fiscalpower:	
Expertise Mileage:	**110093**	Power Kw:	**100**
Bodytype:		Body colour	**Steel Grey**
Gearbox:	**Automatic**	Paint type	**Metalic**
Transmission:		Type of rims (mounted)	**Aluminium**
Fueltype:	**Electric**	Parking lot	**631**
Number of seats	**5**		
Type of rims (mounted)	**Aluminium**		
Maintenance needed	**No**

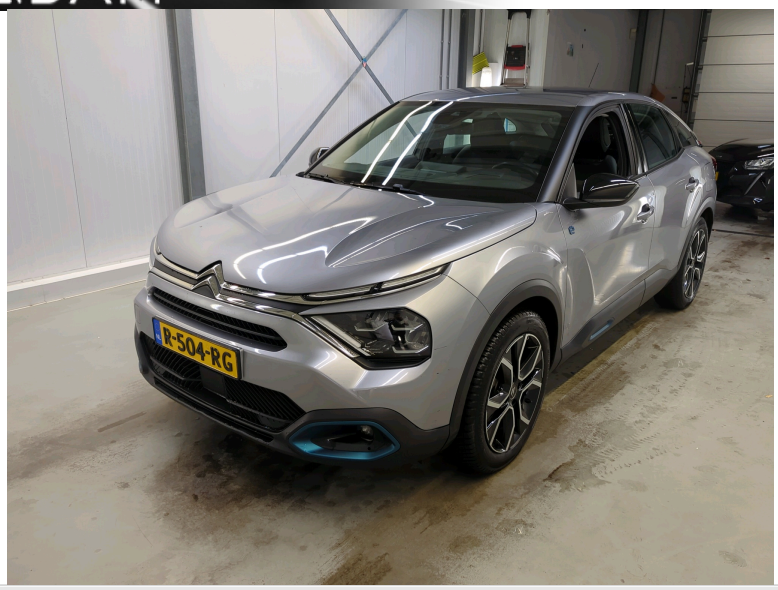
Door FL, Dent(s) and scratch(es), Repair and paint (complete)

Wing RL, Scratch(es), Repair and paint (complete)

Door RL, Scratch(es), Repair and paint (complete)

Roof pillar L, Scratch(es), Repair and paint (complete)

Wing FL, Scratch(es), Repair and paint (complete)

Bumper F, Scratch(es), Repair and paint (complete)

Windscreen, Stone chip(s), Windscreen repair

Wing RR, Dent(s) and scratch(es), Repair and paint (complete)

Door FR, Dent(s) and scratch(es), Repair and paint (complete)

Bumper R, Dent(s) and scratch(es), Repair and paint (complete)

Roof, Chemical polution, Polish
