Expertise

Protocol number: 48412470
Order No. / Reference: 27114975
Inspection date: 29 Oct 2026

Manufacturer: Skoda	Model: Octavia Combi 2.0 TDI DSG 4x4 RS
VIN: TMBLK8NX5RY014938

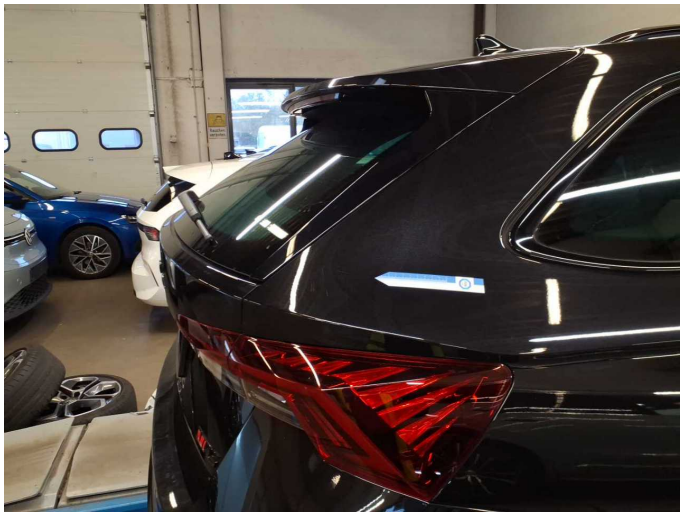
No.	Component group	Description
1	Side panel - rear right side	Side panel - Scratch(es) - Paint
2	Rear bumper	Rear bumper - Scratched - Repair and paint

Damage 1: Side panel - rear right side: Side panel - Scratch(es) - Paint
