TÜV SÜD Auto Partner GmbH
Wiesenring 2
04159 Leipzig

# Expertise

Protocol number: 48238782
Order No. / Reference: 27111734
Inspection date: 19 Oct 2026

| Manufacturer: Seat | Model: Tarraco 2.0 TDI SCR Style |

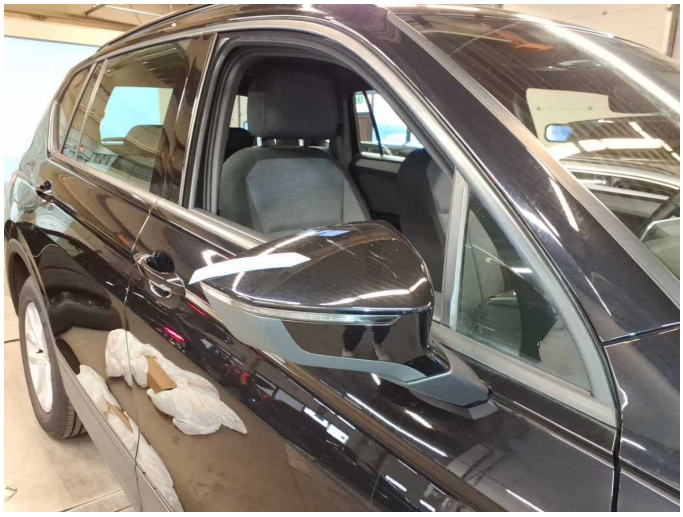
| No. | Component group | Description |
|---|---|---|
| 1 | Door - front right side | Door (schleifen + polieren) - Scratch(es) - Smart repair |

**Damage 1:** Door - front right side: Door (schleifen + polieren) - Scratch(es) - Smart repair

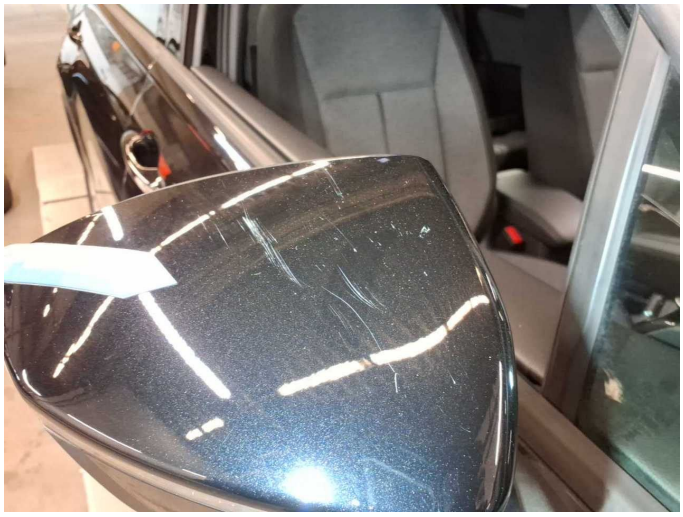
| No. | Component group | Description |
|---|---|---|
| 2 | Wing mirror - right side | Cap - Scratch(es) - Smart repair |

**Damage 2:** Wing mirror - right side: Cap - Scratch(es) - Smart repair

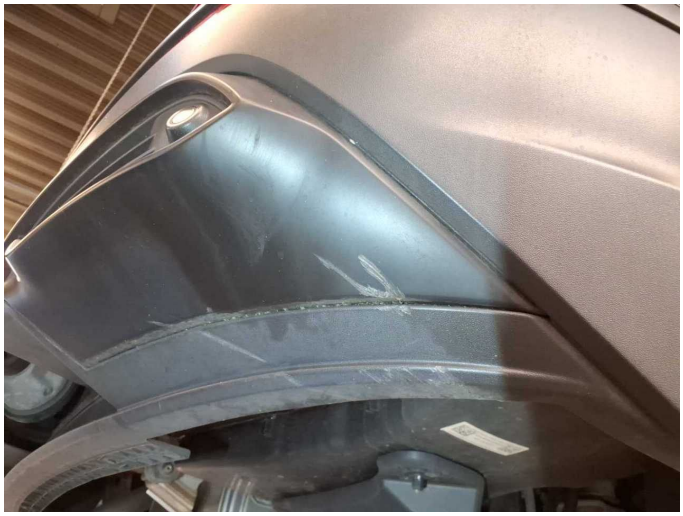
| No. | Component group | Description |
|---|---|---|
| 6 | Rear bumper | Spoiler - Scratched - Replace |

**Damage 6:** Rear bumper: Spoiler - Scratched - Replace

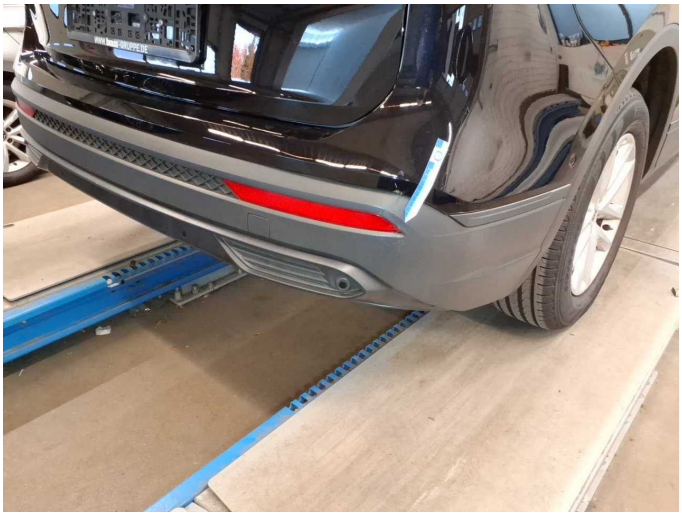
**Damage 6:** Rear bumper: Spoiler - Scratched - Replace
