Expertise

Protocol number: 48516639
Order No. / Reference: 27250160
Inspection date: 31 Oct 2026

Manufacturer: Ford	Model: Transit 310 L2H2 Lkw VA Trend Kasten
VIN: WF0EXXTTRELC55776

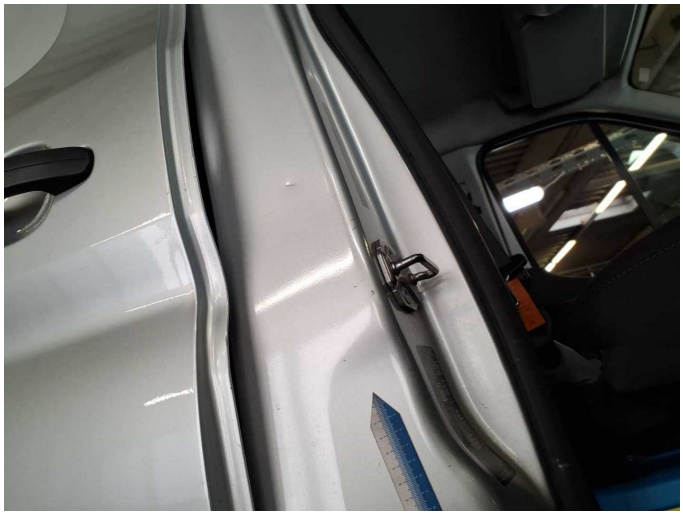
No.	Component group	Description
1	Sill - right side	Sill - Scratch(es) - Smart repair
2	Front bumper	Front bumper - Scratched - Loss in value
3	Rear bumper	Rear bumper - Scratch(es) - Loss in value
4	Boot lid / rear door	Rear door - left side - Scratch(es) - Loss in value
5	Boot lid / rear door	Rear door - right side - Scratch(es) - Loss in value
6	Rear bumper	Rear bumper - Damaged - Replace

Damage 1: Sill - right side: Sill - Scratch(es) - Smart repair
