ARVAL
BNP PARIBAS GROUP

2CGX456

INSPECTION REPORT

End of contract

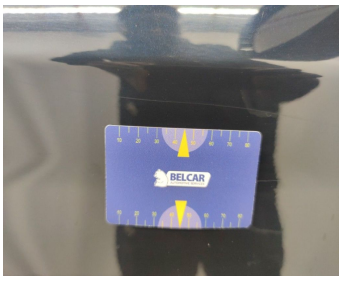
Door Front Left // Smart Repair Medium-scratch

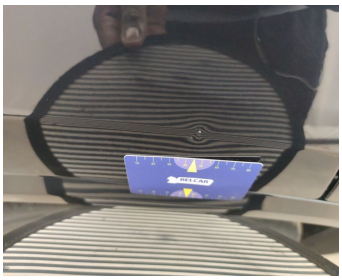
Trunk Lid Interior Coating / Complete Panel / Replace-scratch

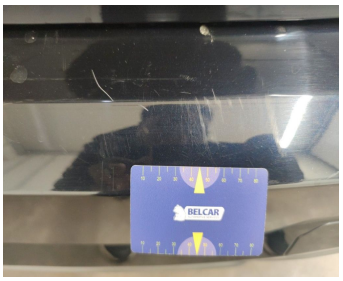
Door Rear Right / Trim / Replace-scratch
